## NEW HAMPSHIRE DOT STORM PIPE REHABILITATION USING GEOPOLYMER LINING SYSTEM

**Project:** New Hampshire DOT - Culvert Slipline Rehabilitation NH-114 Over Bowman Brook

**Location:** Bedford, NH

### STRUCTURAL REHABILITATION OF CORRUGATED METAL STORM PIPE USING QLS SPIN-CAST GEOKRETE PIPE LINING SYSTEM

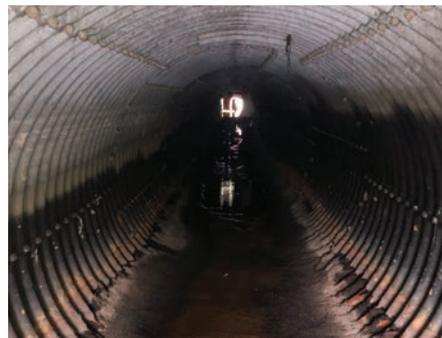
A CMP storm culvert, installed by the New Hampshire DOT decades ago, had seen better days. Due to its age, the structural integrity of a 210 LF of 90" corrugated metal storm pipe had been compromised. There was so much corrosion, the invert had completely degraded and was missing; causing the culvert pipe to depress and take on more of an elliptical shape from the original 90" round shape. Complicating the issue was the discovery of missing pipe sections... again due to years of use and corrosion build-up over time. Left unrepaired, the roadway above would begin to sink and potentially lead to a collapse of the pipe and roadway.

*Compromised 90" Corrugated Metal Pipe*

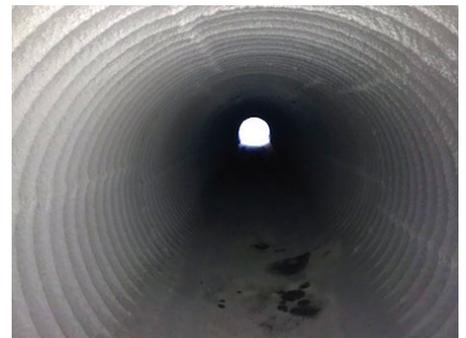
*CMP Restored Using The Quadex Lining System*

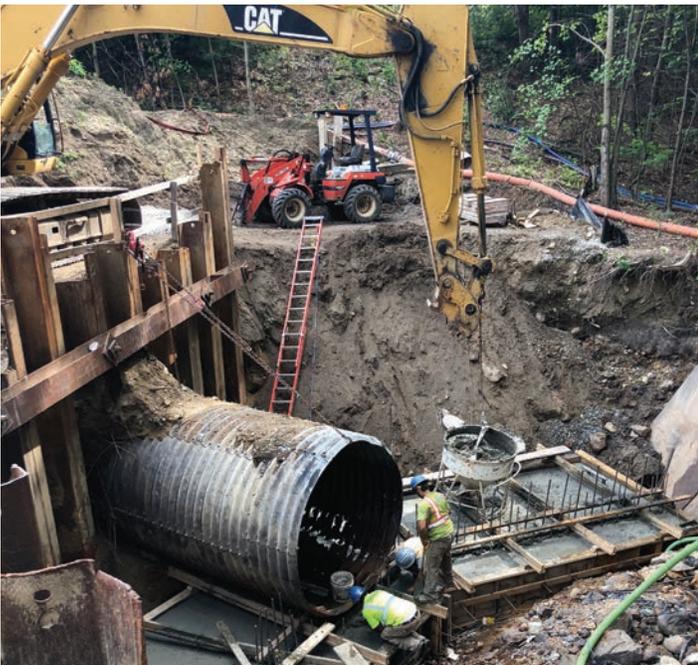
*NHDOT culvert required significant reinforcement as part of the entire rehab process.*

On this project, a bypass system was required to divert the brook and stormwater flow. Once operational, the culvert was cleaned, debris was removed and extensive invert repairs were made. In addition, the portions of missing pipe (at 3 o'clock and 9 o'clock) were also repaired. Typically a reinforcing mesh or grate, combined with hand-troweled GeoKrete®, fill these voids prior to the pipe relining. Once done, GeoKrete was precision spin-cast to a 2" thickness design. The completed project met all objectives and requirements set prior to repair and was the first approved and completed GeoKrete geopolymer lining installation with the New Hampshire Department of Transportation.

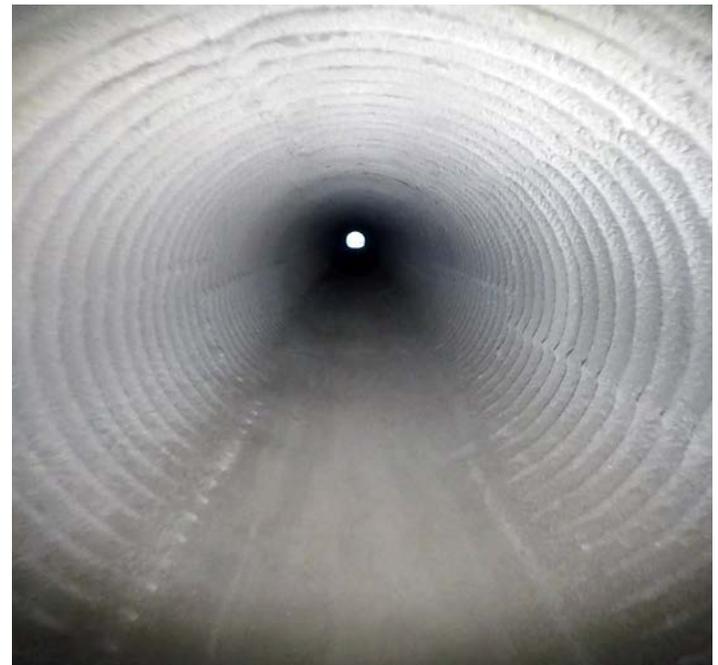
*Post installation inspection of the GeoKrete lined culvert shows precision and cleanliness of the application.*

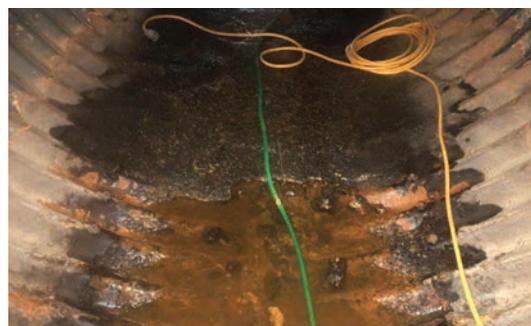
*Previous attempts to reline the corroded invert had failed.*
