CASE STUDY

SEVERELY CORRODED MANHOLE REHABILITATED WITH GEOKRETE® GEOPOLYMER SHOW NO SIGNS OF DEGRADATION

- Emergency manhole rehabilitation

- City of Hot Springs Village, AR

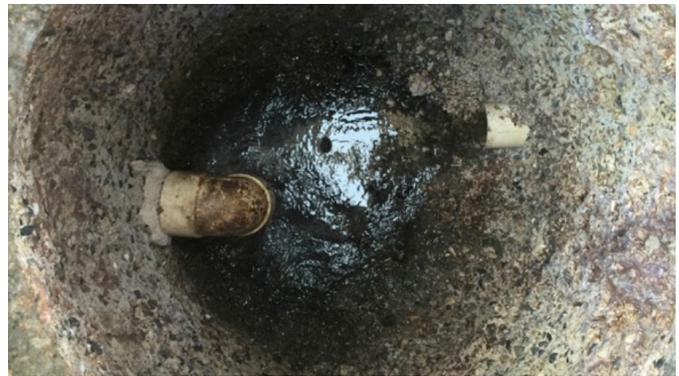
A collection system was experiencing unusually high and consistent levels of H₂S gas (165-190 ppm). One manhole in particular had completely deteriorated and was originally thought to be beyond repair. The corrosion was so bad, that when the walls were water blasted at 4,000 psi, old concrete and aggregate completely washed away to the soil level in some areas.

2014 - High H₂S levels caused this manhole to quickly deteriorate to a point where structural integrity and I&I were an issue.

Once the walls were water blasted, the Quadex crew applied Hyperform®, a quick setting patching material, to fill the large voids in preparation for lining.

A certified Quadex applicator spray-applied the GeoKrete to a 1.5" thickness. A trowel was then used to create a smooth finish.

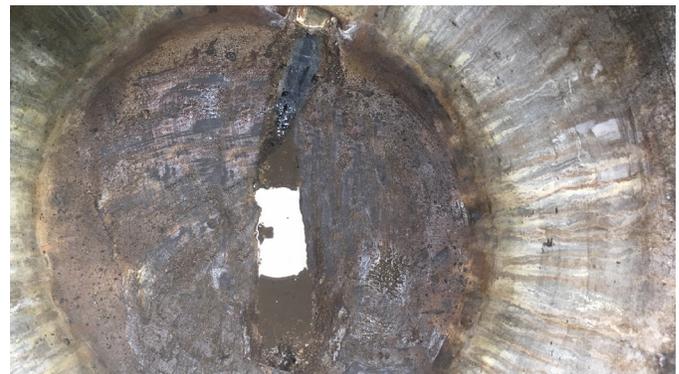
2018 - Approximately 4 years later the GeoKrete lined manhole shows no signs of degradation.

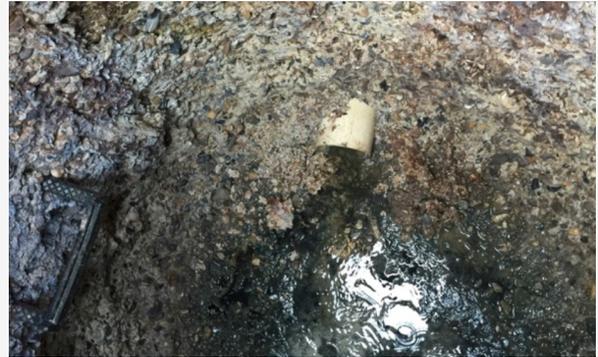
The corrosion was so bad, the manhole needed to be completely reprofiled.

A new flow channel also had to be constructed at the manhole's base. The original was so deteriorated and started to dissolve during the water blasting procedure.

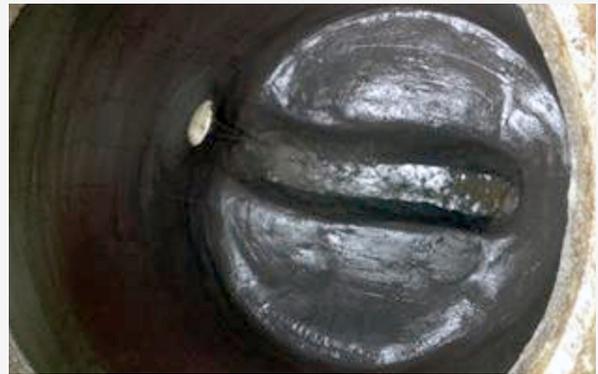
2014 - This photo shows the manhole just after it was lined with Geokrete. Note the smooth finish and rebuilt flow channel at the bottom.
