STORM DRAIN SYSTEM RELINED TO PREVENT INFILTRATION OF DIESEL FUEL CAUSED BY SPILL IN KALAMAZOO TRAIN YARD

Quadex® Structure Guard® 100% Solids Epoxy Used to Rehabilitate the Manholes and Catch Basins

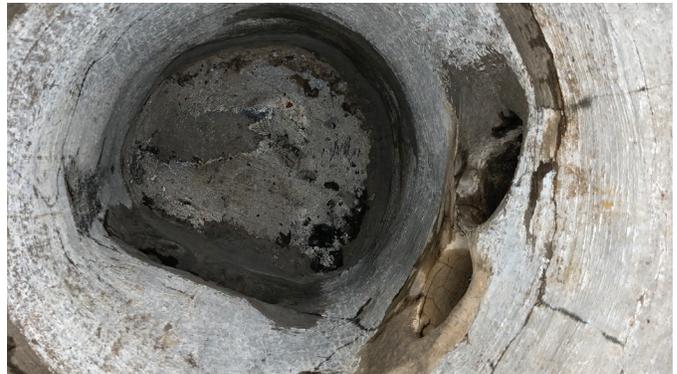
Before lining - cracks and voids are noticeably visible in this leaking manhole.

basins that varied from 5' - 10' in depth. While the contractor performed the necessary CIPP portion of the project, a sub-contractor was hired to reline the manholes and catch basins. From the beginning, there were problems and concerns with the sub-contractor's ability to properly apply the cementitious liner. That initial concern proved to be valid, since the manholes failed several exfiltration tests.

Based on previous success in similar environments, Vortex Services recommended Structure® Guard, a 100% solids epoxy coating system, to address and eliminate the potential environmental hazard. Structure Guard® is widely known for exceptional bond strength and its long-term chemical and corrosion resistance. To plug the leaking voids and cracks, I&I Guard®-PRF, a fast-setting water stop product, was also specified.

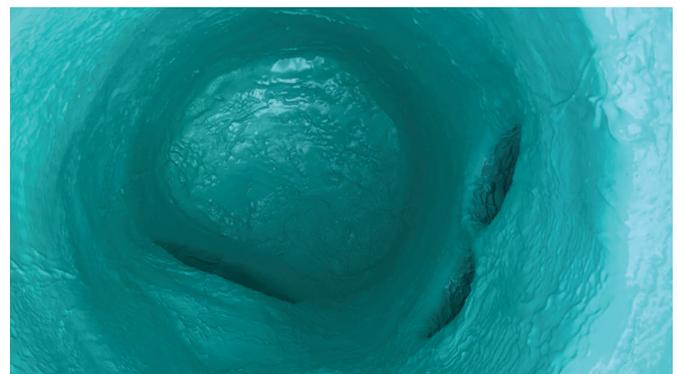
After lining with Structure Guard 100% solids epoxy — smooth troweled for an impermeable, corrosion resistant finish.

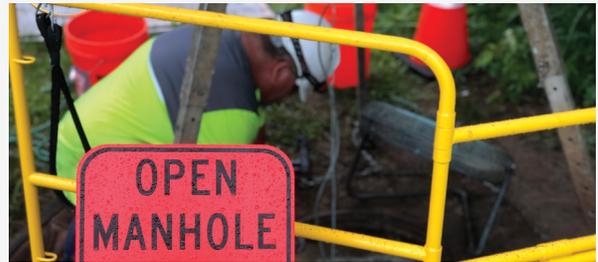
Vortex Services crew applies Structure Guard®

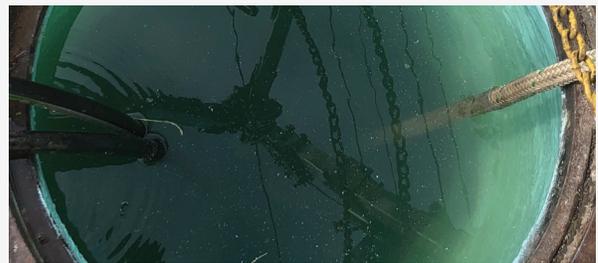
Once completed, the newly-lined manholes and catch basins were tested for infiltration and exfiltration. In each case, they exceeded the testing standards.

Lined manhole is filled with water for leak (exfiltration) testing. No leaks present.

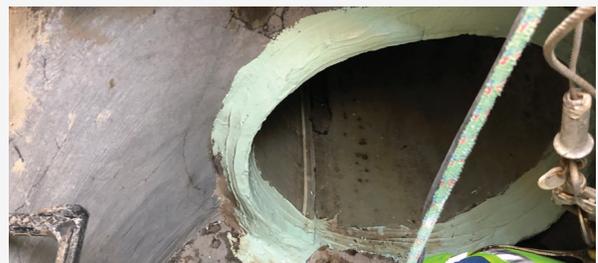
I&I Guard-PRF was applied to fill voids and cracks in manhole and pipe entry points.

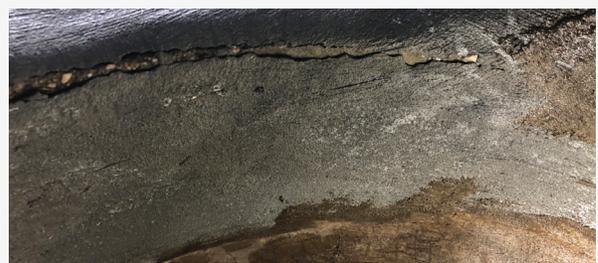
Cracks reveal failed cementitious liner from original project.

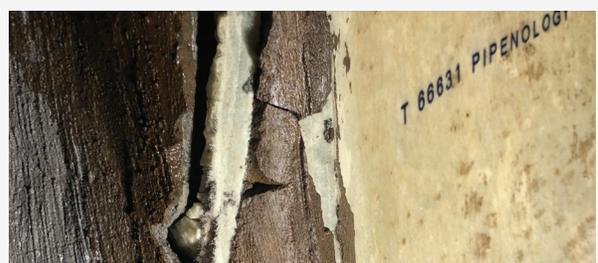
If left unrepaired, cracks like this would have allowed inflow of diesel fuel into the storm drain system.
