## PROTOTYPE APPLICATION OF THE QUADEX LINING SYSTEM® FEATURING GEOKRETE® GEOPOLYMER

- Bentonville, AR

### Collapsed and Corroded Culvert Structurally Relined, Avoiding the Need for Intrusive Excavation.

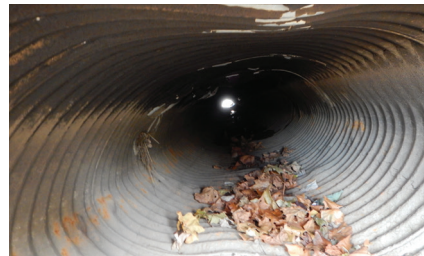
July 2015  
Pipe sections showed signs of partial collapse.

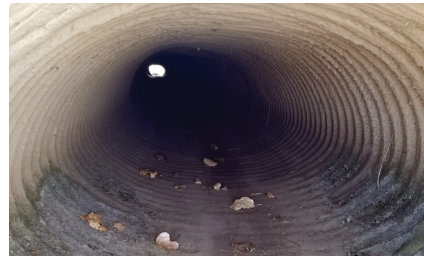
October 2017  
Section of pipe where partial collapse existed remains in excellent shape after it was structurally relined with GeoKrete.

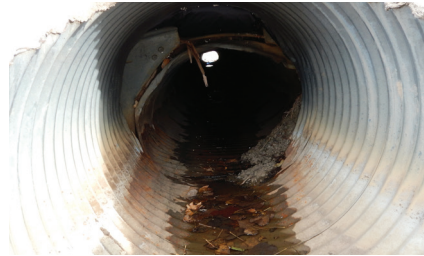
July 2015  
Complete joint failure with pipe suffering from severe ovality, I&I and threat of total collapse.

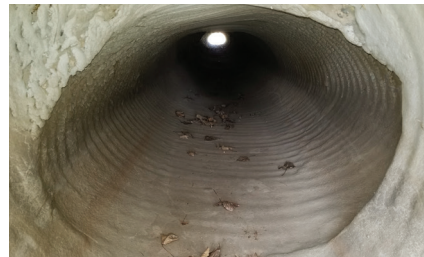
October 2017  
No signs of joint failure or ovality as depicted in the host pipe. Structural GeoKrete liner is intact and continues to provide corrosion protection.
