OHIO DOT CULVERT REHABILITATION

ODOT: 50+ Year-Old Culvert in Remote Location Structurally Restored with GeoKrete® Geopolymer

ODOT: 78" CULVERT RELINED WITH QLS

Failing 62-Year-Old Corrugated Metal Pipe Gets New Life

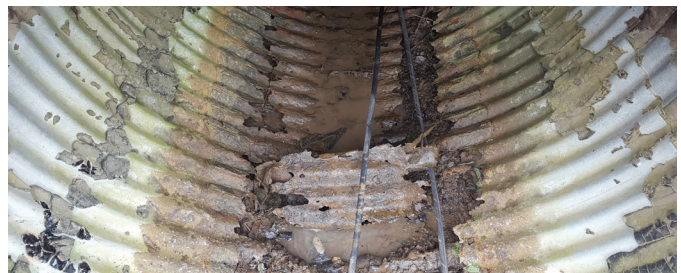
- Culvert installed in 1963. Invert was completely deteriorated and there was extensive corrosion on the inner pipe wall.

A 50+ year old CMP storm culvert pipe in Guernsey County, OH was found to be in very bad condition. The invert was nearly gone and corrosion inside the pipe threatened a complete failure in the near future.

This old CMP culvert was completely corroded through in many areas.

Once in place, the old culvert was cleaned, prepped and patched before the relining process started. In addition to rebuilding the invert, the QLS crew relined the 54" CMP pipe over period of three days. A total of two passes were made by QLS's advanced application sled, to achieve a thickness of 1.5".

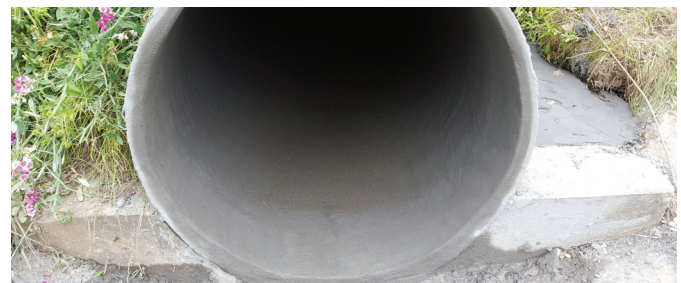
QLS GeoKrete was spin-cast for a smooth, structural and corrosion resistant finish.

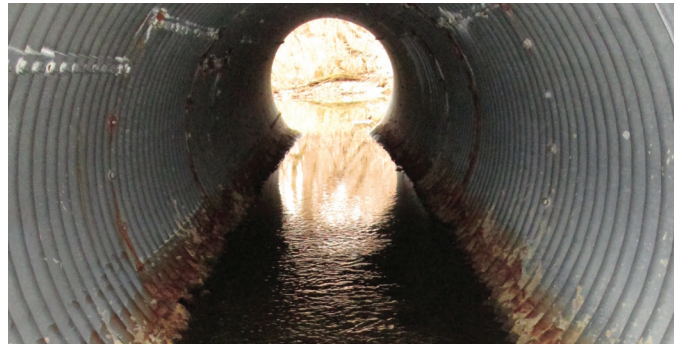
- Culvert installed in 1954. Invert was in poor condition and existence of corrosion on pipe's inner walls. Running beneath a roadway, a full structural renewal was required.

A 78" CMP storm drain running beneath a road in Loveland, Ohio had begun to fail. With the invert in need of repair and corrosion eating at the inside, complete failure was imminent. The 62 year-old pipe had exceeded its design life and needed to be structurally restored, or ultimately it would need to be replaced.

78" CMP was corroded and failing.

RB Jergens, the prime contractor, recommended the Quadex® Lining System as an alternative to replacement. The system features GeoKrete® Geopolymer and possesses both excellent corrosion resistance and structural properties. In this case, GeoKrete was spray-applied to achieve a thickness of 2" to protect and restore the culvert to its original integrity. The roadway above was never closed, however a temporary traffic signal (to control traffic flow) was installed in conjunction with the lining work to ensure proper safety for all crews involved.

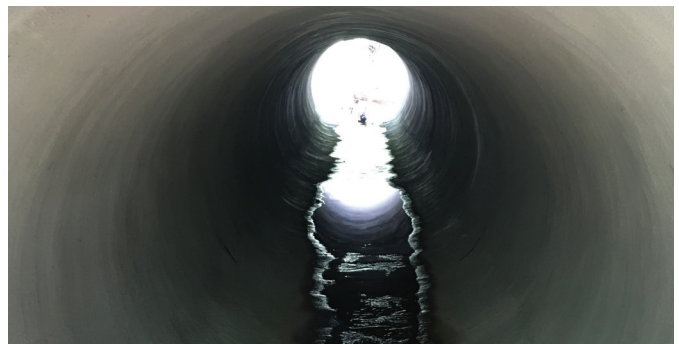
QLS GeoKrete was spray-applied, then troweled to achieve a smooth consistent thickness.
