- D-4 Pump Station Stormwater Outfall Rehabilitation

PUMP STATION OUTFALL REHABILITATION IN PALM BEACH, FLORIDA PREVENTS FUTURE DAMAGE TO HOME AND ROAD

A Failing, 350 LF Stormwater Outfall, in an Exclusive Palm Beach, FL Residential Community, is Fully Rehabilitated to Avoid Imminent Damage and Potential Sinkage of Nearby Home.

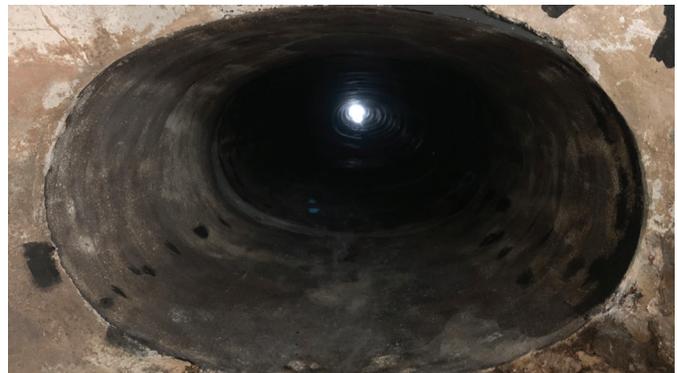
Before

A stormwater outfall serving an exclusive residential community in Palm Beach, Florida had been deteriorating for years. Its proximity to the intracoastal waterway and exposure to a saltwater environment had simply taken their toll. Previous attempts to restore the pipe's integrity had failed and the city was seeking a more permanent structural rehabilitation solution.

Without a quick repair, there were legitimate concerns about the outfall's structural integrity due to its continued degradation. If the pipe collapsed, sink holes could have formed and a nearby home and road above would have suffered severe damage as a result.

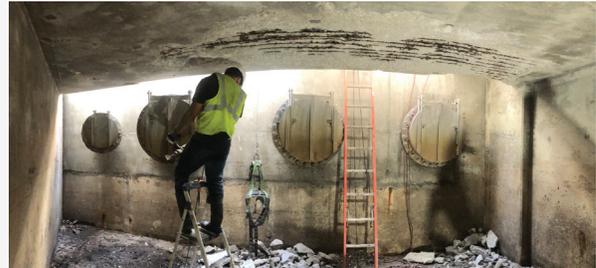
Clear evidence of concrete delamination in the D-4 Pump Station.

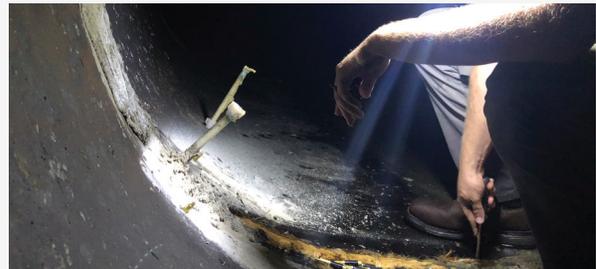
Leaks at the pipe joints were prepped and sealed with I&I Guard-PRF.

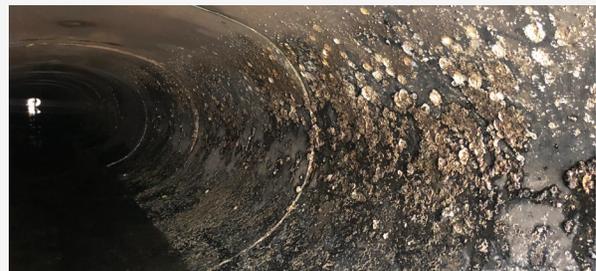
Concrete was deteriorating and joints were leaking.
