HOT SPRINGS VILLAGE, ARKANSAS: SEVERELY CORRODED MANHOLE REHABILITATED WITH GEOKRETE® GEOPOLYMER SHOW NO SIGNS OF DEGRADATION

Emergency manhole rehabilitation

City of Hot Springs Village, AR

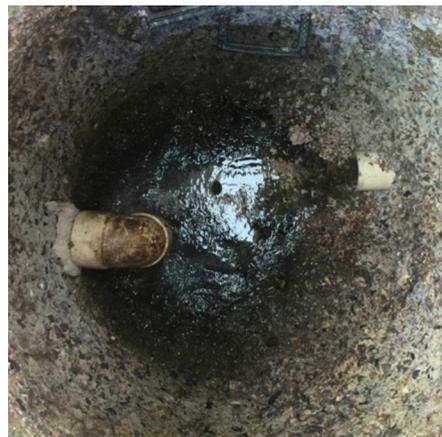
A collection system was experiencing unusually high and consistent levels of H₂S gas (165-190 ppm). One manhole in particular had completely deteriorated and was originally thought to be beyond repair. The corrosion was so bad, that when the walls were water blasted at 4,000 psi, old concrete and aggregate completely washed away to the soil level in some areas.

2014 - High H₂S levels caused this manhole to quickly deteriorate to a point where structural integrity and I&I were an issue.

Once the walls were water blasted, the Quadex crew applied Hyperform®, a quick setting patching material, to fill the large voids in preparation for lining.

A certified Quadex applicator spray-applied the GeoKrete to a 1.5" thickness. A trowel was then used to create a smooth finish.

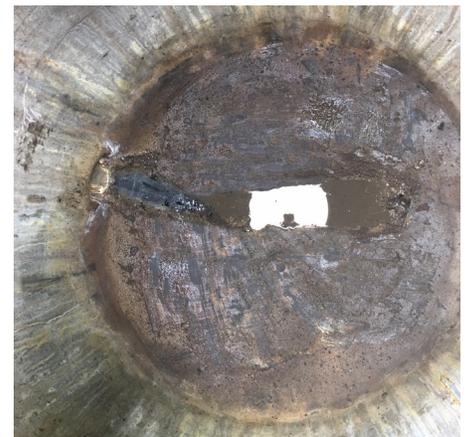
2018 - Approximately 4 ½ years later the GeoKrete lined manhole shows no signs of degradation.

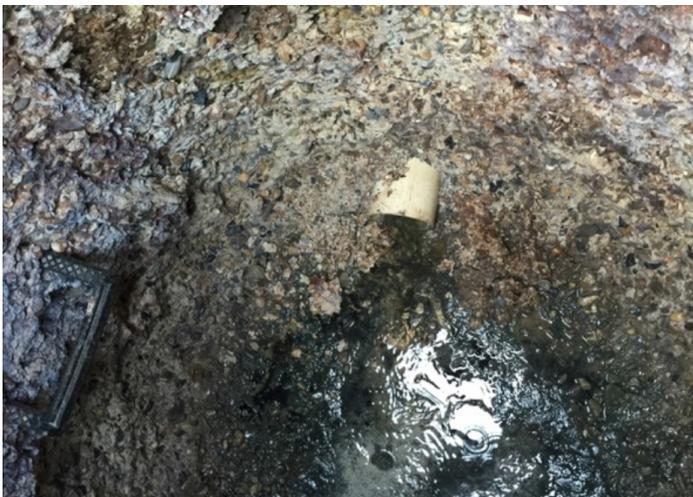
The corrosion was so bad, the manhole needed to be completely reprofiled.

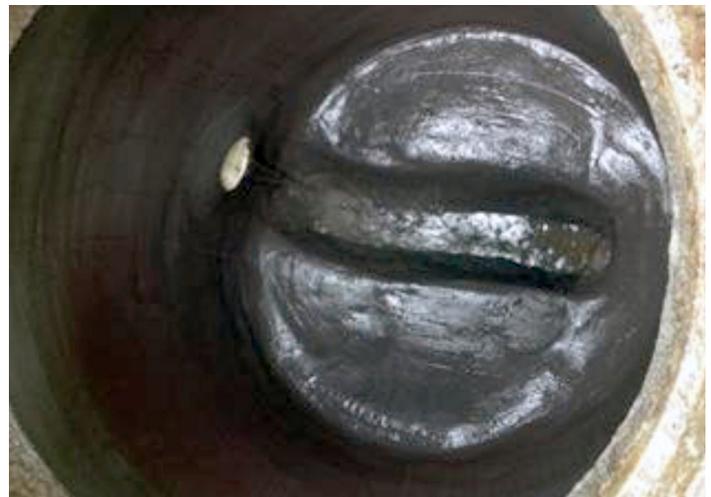
2014 - This photo shows the manhole just after it was lined with Geokrete. Note the smooth finish and rebuilt flow channel at the bottom.

A new flow channel also had to be constructed at the manhole's base. The original was so deteriorated and started to dissolve during the water blasting procedure.
