STORM DRAIN SYSTEM RELINED TO PREVENT INFILTRATION OF DIESEL FUEL CAUSED BY SPILL IN KALAMAZOO TRAIN YARD.

QUADEX® STRUCTURE GUARD® 100% SOLIDS EPOXY USED TO REHABILITATE THE MANHOLES AND CATCH BASINS

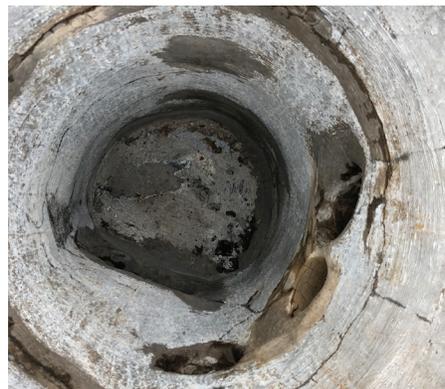
Before lining - cracks and voids are noticeably visible in this leaking manhole.

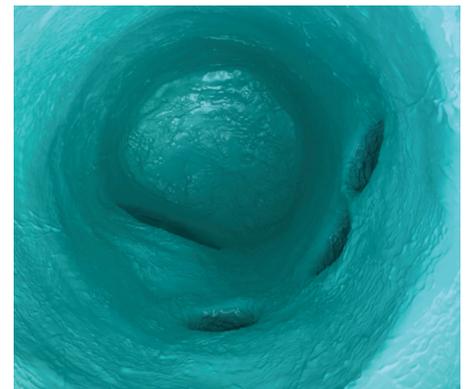
After lining with Structure Guard 100% solids epoxy — smooth troweled for an impermeable, corrosion resistant finish.

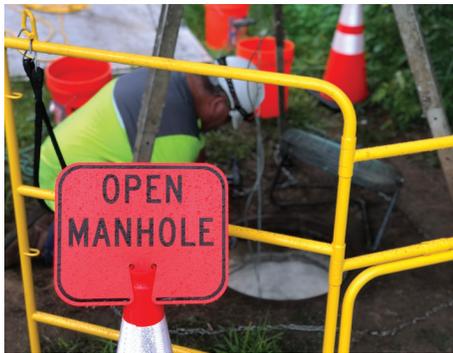
Vortex Services crew applies Structure Guard®

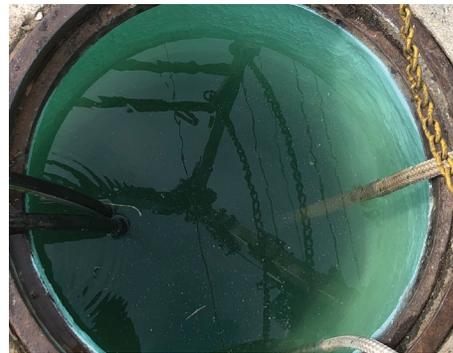
Lined manhole is filled with water for leak (exfiltration) testing. No leaks present.

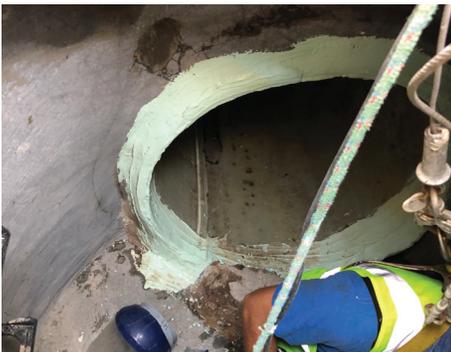
I&I Guard-PRF was applied to fill voids and cracks in manhole and pipe entry points.

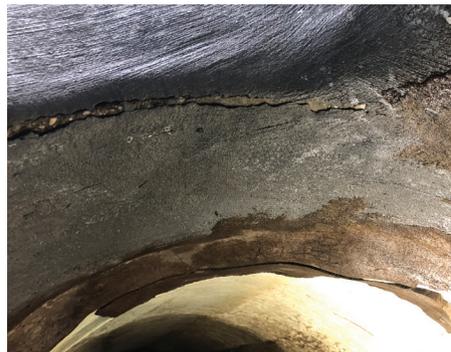
Cracks reveal failed cementitious liner from original project.

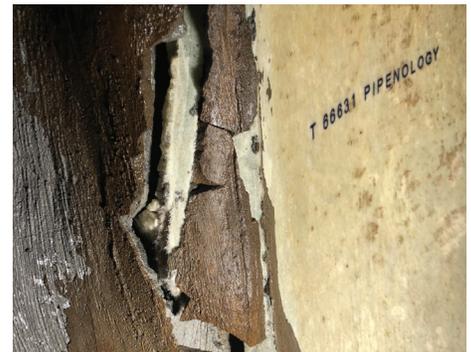
If left unrepaired, cracks like this would have allowed inflow of diesel fuel into the storm drain system.
