NEW HAMPSHIRE DOT STORM PIPE REHABILITATION USING GEOPOLYMER LINING SYSTEM

Project: New Hampshire DOT - Culvert Slipline Rehabilitation NH-114 Over Bowman Brook

STRUCTURAL REHABILITATION OF CORRUGATED METAL STORM PIPE USING QLS SPIN-CAST GEOKRETE PIPE LINING SYSTEM

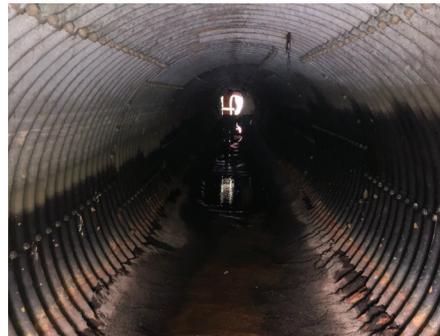
A CMP storm culvert, installed by the New Hampshire DOT decades ago, had seen better days. Due to its age, the structural integrity of a 210 LF of 90" corrugated metal storm pipe had been compromised. There was so much corrosion, the invert had completely degraded and was missing; causing the culvert pipe to depress and take on more of an elliptical shape from the original 90" round shape. Complicating the issue was the discovery of missing pipe sections... again due to years of use and corrosion build-up over time. Left unrepaired, the roadway above would begin to sink and potentially lead to a collapse of the pipe and roadway.

Compromised 90" Corrugated Metal Pipe

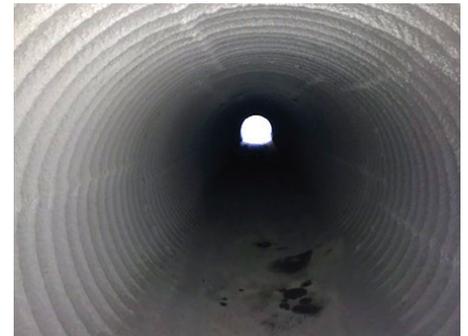
CMP Restored Using The Quadex Lining System

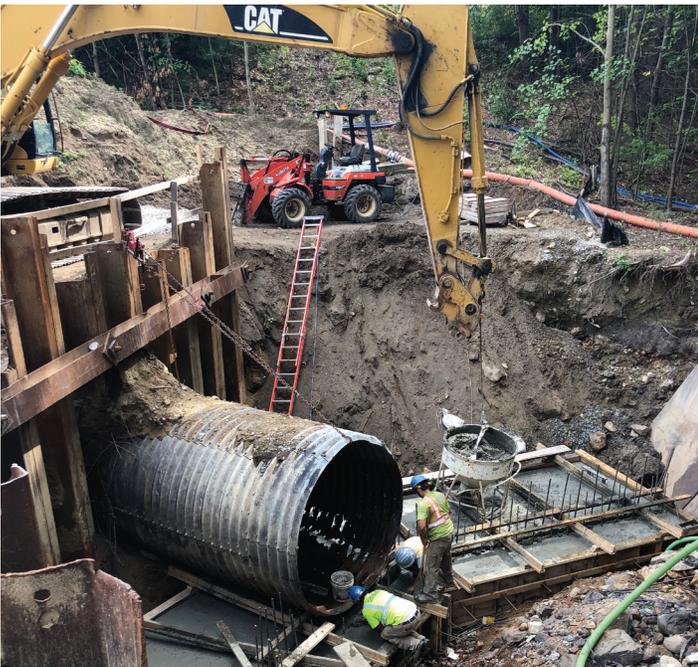
NHDOT culvert required significant reinforcement as part of the entire rehab process.

On this project, a bypass system was required to divert the brook and stormwater flow. Once operational, the culvert was cleaned, debris was removed and extensive invert repairs were made. In addition, the portions of missing pipe (at 3 o'clock and 9 o'clock) were also repaired. Typically a reinforcing mesh or grate, combined with hand-troweled GeoKrete®, fill these voids prior to the pipe relining. Once done, GeoKrete was precision spin-cast to a 2" thickness design. The completed project met all objectives and requirements set prior to repair and was the first approved and completed GeoKrete geopolymer lining installation with the New Hampshire Department of Transportation.

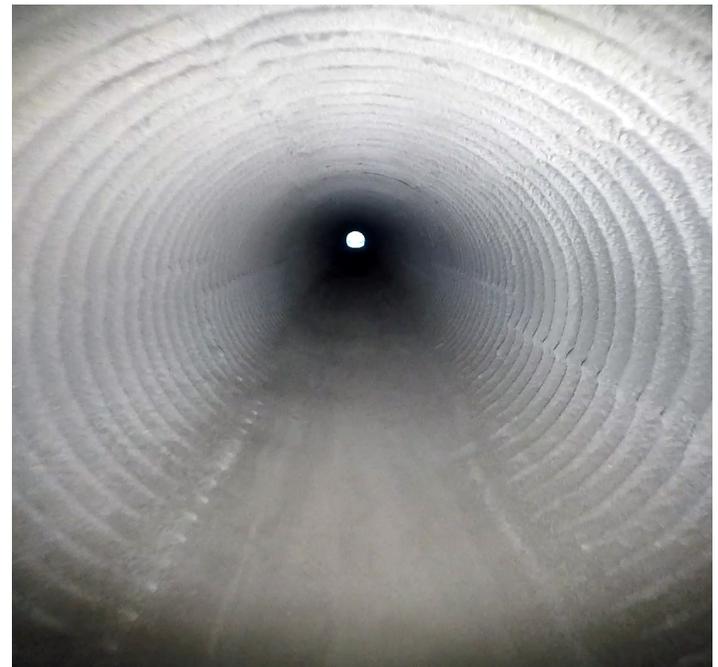
Post installation inspection of the GeoKrete lined culvert shows precision and cleanliness of the application.

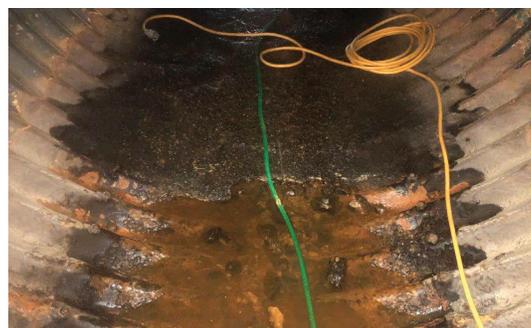
Previous attempts to reline the corroded invert had failed.
