AEP NIAGARA HYDRO ELECTRIC PLANT 78" & 66" STEEL PENSTOCKS

Penstock Restoration

FAILING PENSTOCKS, STEEP SLOPES MAKE FOR DIFFICULT PIPE REHABILITATION

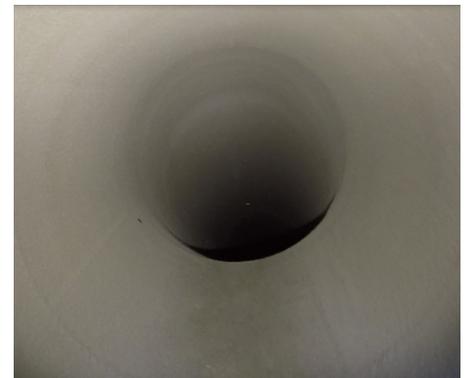
Penstock pipe after GeoKrete® application.

Although the job was unique in the pipe's extreme slope, the application of GeoKrete was not altered. Prior to lining, the failed polyurethane liner was removed and the pipe was prepped and patched where necessary. Ready for application, the QLS sled was able to precisely spin-cast the GeoKrete, at a 1" thickness, onto the inner wall of the penstocks. The application sled is winch-controlled to allow for consistent and uniform application throughout the entire length of the pipe.

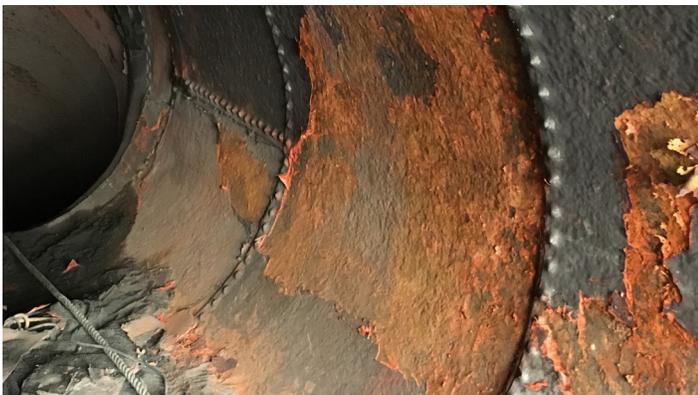
The plant's two penstocks — which are the pipes that carry water down from the hydroelectric reservoir to the turbines inside the plant — were compromised with pin holes and weak spots. Each is fed by dual lines, combined into one just before the turbine. One was two (2) 78" in diameter lines totaling 115' long, while the other was one (1) 78" diameter line and one (1) 66" in diameter line, each 57.5' long. The lines had been treated in 1994 with a polyurethane liner... it had failed.

Urethane removal was tedious

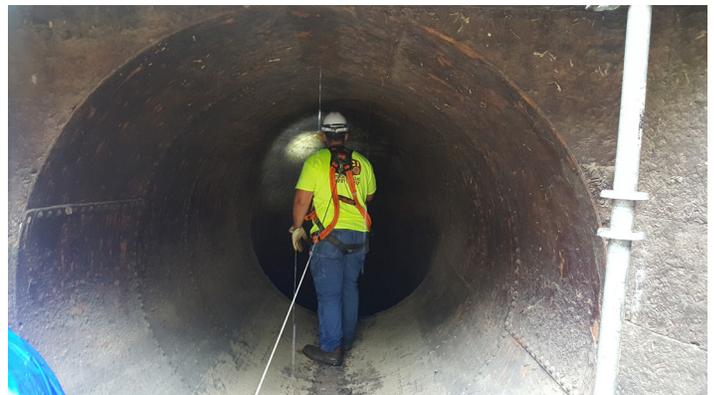
Peering down the steep slope of penstock.

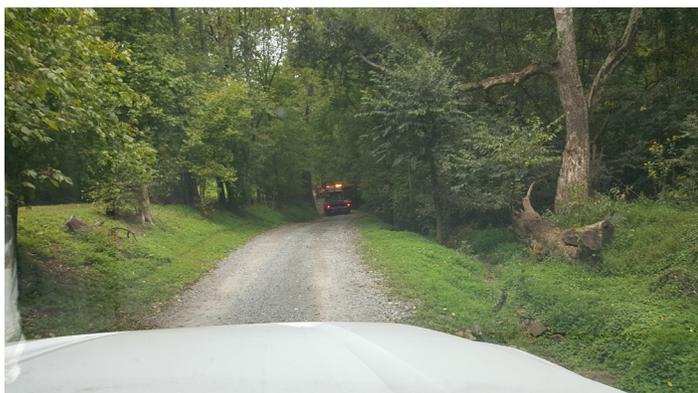
The CIPP process was considered but the combination of limited access and steep grades would have made it very expensive and too risky. The pipe entry was down an embankment that didn't allow vehicles, not to mention the site's access was extremely limited and would have required a helicopter to get CIPP liner into place.

Remote access and narrow pathways.

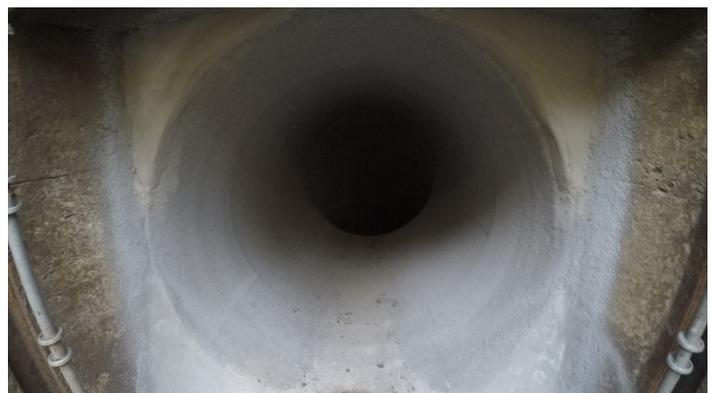
GeoKrete Liner - Structural renewal & restored flow capacity.
