PUMP STATION OUTFALL REHABILITATION IN PALM BEACH, FLORIDA PREVENTS FUTURE DAMAGE TO HOME AND ROAD

D-4 Pump Station Stormwater Outfall Rehabilitation

City of Palm Beach, FL

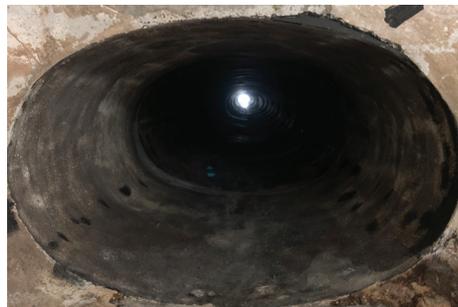
Before

A stormwater outfall serving an exclusive residential community in Palm Beach, Florida had been deteriorating for years. Its proximity to the intracoastal waterway and exposure to a saltwater environment had simply taken their toll. Previous attempts to restore the pipe's integrity had failed and the city was seeking a more permanent structural rehabilitation solution.

- Pipe Prep: Marine growth and cold tar epoxy from early repair attempts had to be removed via a combination of sand blasting and hydro blasting.
- Arrest Water Infiltration: I&I Guard®-PRF, a polyurethane grout, and Quadex® Quad-Plug® were used to stop the fast flowing leaks from cracks and large gaps.
- Address Delaminating Concrete: The crew removed loose material with hammer drills and angle grinders, then primed and repaired the wall with with a hydraulic cement and gel coat.
- Apply Corrosion Protection: Quadex Structure Guard® 100% solids epoxy was spray applied at 175 mil for structural enhancement and corrosion resistance.

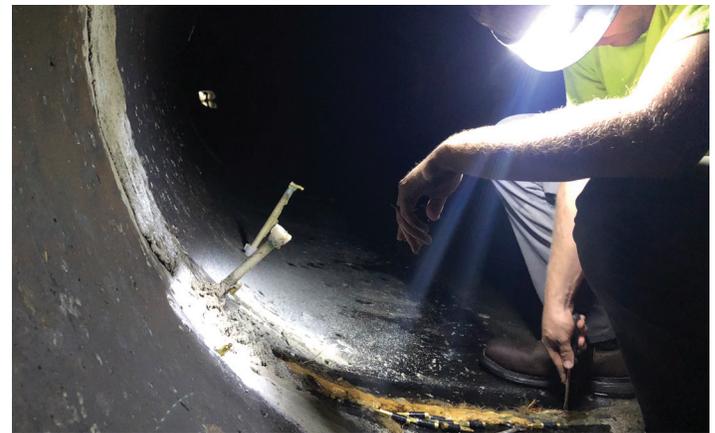
Leaks at the pipe joints were prepped and sealed with I&I Guard-PRF.

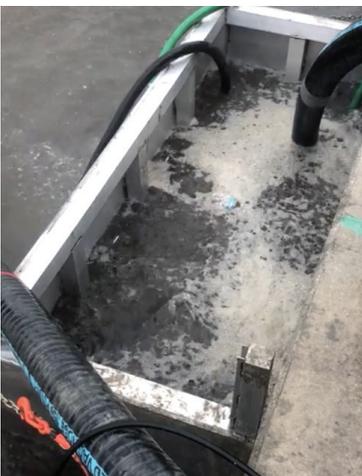
Daily dewatering was necessary due to outfall's proximity to the intracoastal waterway.

The exceptionally high rate of dewatering required an innovative solution to the bypass. Because of normal tidal flow, the outfall was completely submerged under water a significant portion of the day. In order to dewater the tunnel, the Vortex Services crew designed a steel box that was bolted to the pipe wall to attach the bypass pumps. Due to the consistently high water level, this had to be performed by a dive team.

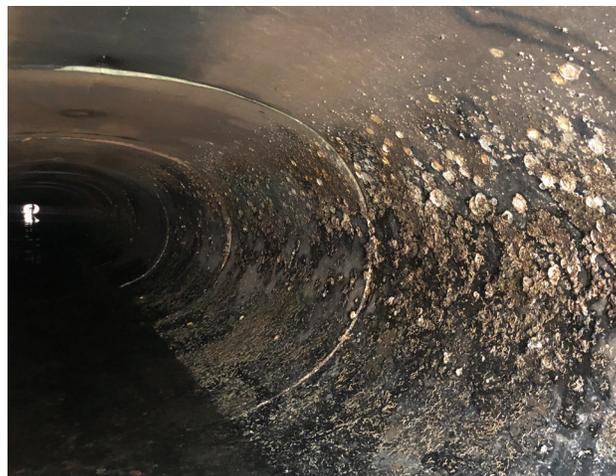
Concrete was deteriorating and joints were leaking.
