WASHINGTON NAVY YARD - STEEL LIFT STATION TANK COMPLETELY REHABILITATED USING STRUCTURE GUARD® 100% SOLIDS EPOXY

Project: Washington Navy Yard - Steel Lift Station Tank Repair

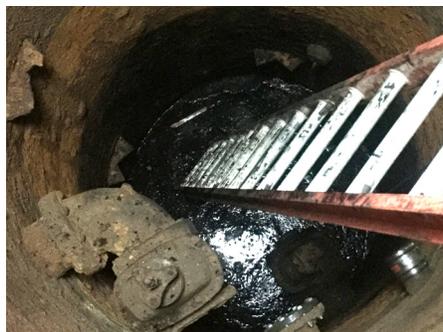
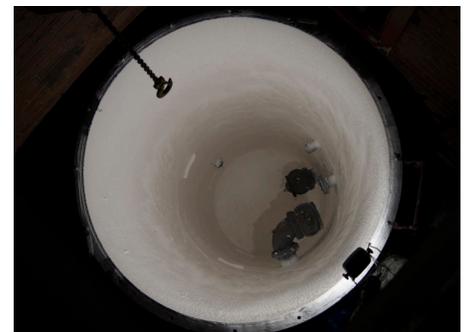
In particular, a steel lift station tank was suffering from severe corrosion and would either need to be completely replaced or rehabilitated.

Several rehabilitation methods and materials were initially discussed. They included hybrid cements, geopolymers and epoxies. After taking a site walk and meeting with the Navy Yard and NICC, the Vortex Services recommended **Structure Guard®**. Being a manufacturer of a wide range of rehabilitation mortars and epoxies, the Vortex Services team was uniquely qualified to recommend the best possible material application for the project environment. In this case the combination of severe corrosion environment and the tank's proximity to the river, Structure Guard was chosen as the rehabilitation method.
