## CASE STUDY: MANHOLE REHABILITATION PILOT TEST - BENTON, AR

### City of Benton, AR Impressed with GeoKrete in Manhole Rehab Pilot Test

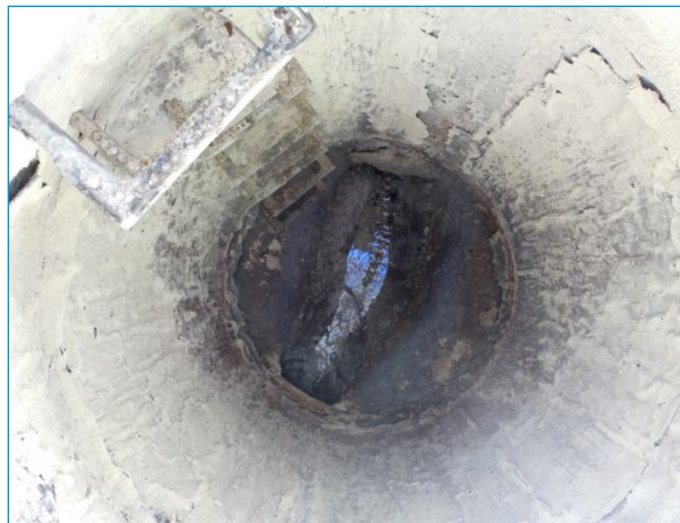
This was a highly corrosive manhole picked by Benton Utilities as a trial / demonstration for Quadex GeoKrete, a structural, corrosion resistant geopolymer mortar. This manhole was approximately 8 ft. in depth and had a forcemain dumping into the manhole upstream. The manhole was in desperate need of a structural lining system containing extreme corrosion resistant properties. H<sub>2</sub>S readings were between 195 & 225 ppm.

The walls were power washed with 4,000 psi and the steps were removed. Because of the severe deterioration of the bench, we rebuilt it higher with Quadex Hyperform to control the flow from spilling over the bench.

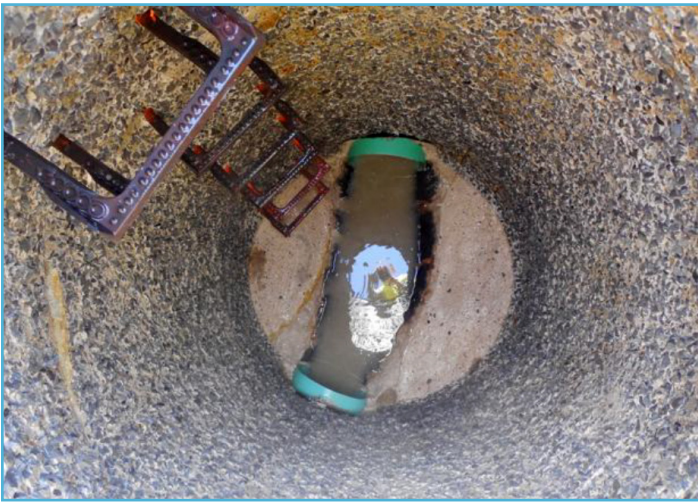
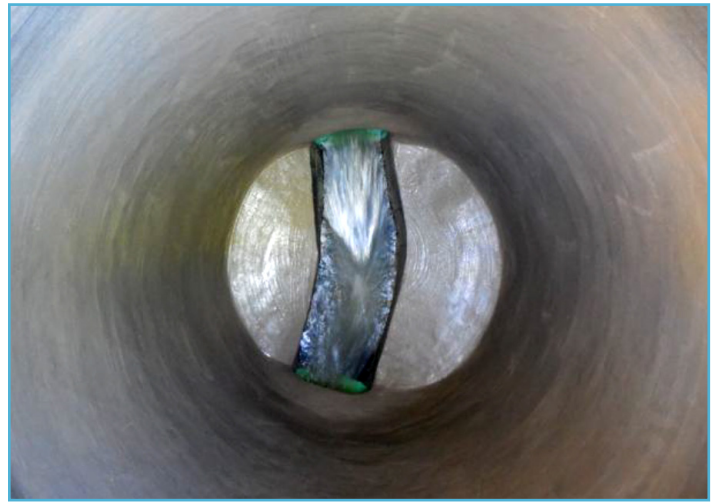
This manhole was lined with with approximately 1 ½ inches of Quadex GeoKrete. This is another successful in-field demonstration of Quadex GeoKrete. After being in the ground for over 1 ½ years, the GeoKrete lined manhole is still structurally sound with no signs of corrosion deterioration present.
