REPAIR
MATERIALS

CASE STUDY: GEOKRETE MANHOLE REHAB PILOT TEST HOT SPRINGS VILLAGE, AR

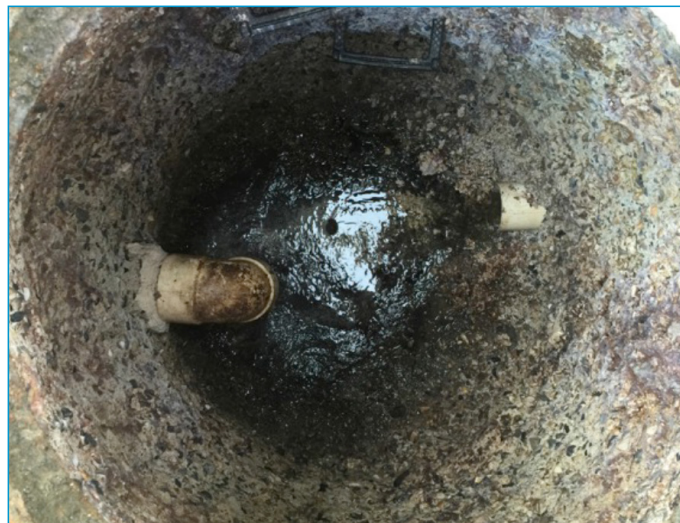
Manhole serving force main, with high H₂S levels, protected with GeoKrete

This manhole was selected by Hot Springs Village to be lined. HSV collection system has a severe H₂S issue and wanted an economic means of rehabilitating their manholes.

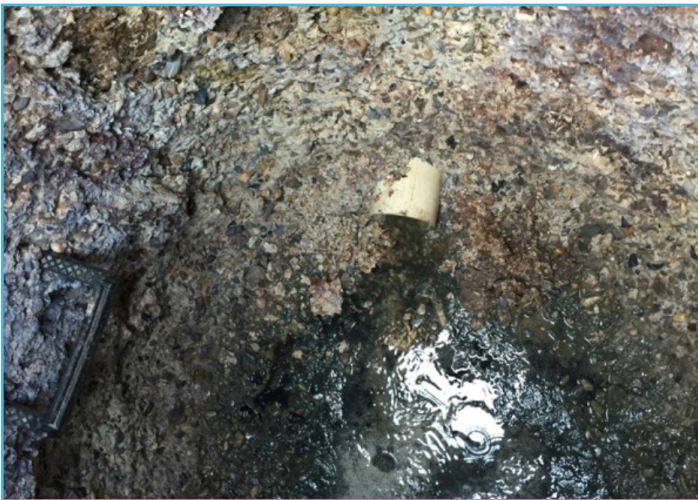
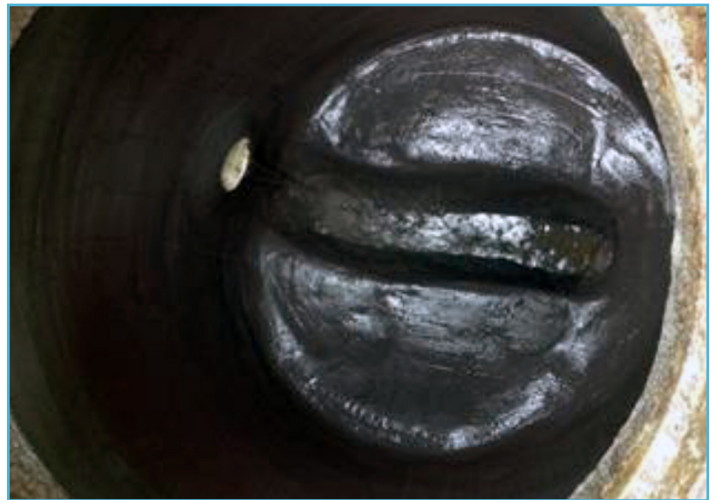
The walls of this manhole were detrimentally impacted from the corrosion. The walls were water blasted with 4,000 psi and were completely washed back to soil in some areas.

Quadex patched the large voids and built a bottom, creating a flow channel with Quadex Hyperform and lined the walls with Quadex GeoKrete. One more successful in-field trial and one more satisfied customer.
