CASE STUDY: KCMO MANHOLE REHAB TRIAL USING GEOKRETE

- **PROJECT:**
GeoKrete Manhole Rehab Trial
- **Owner:**
KCMO
- **PROBLEM:**
Highly corroded manhole, connected to force main, in need of corrosion protection. H²S levels ranged from 165-190 ppm.
- **APPLICATION:**
 - > HyperForm Rapid Setting Patching Material
 - > GeoKrete - 1 1/2" on walls. Troweled to smooth finish.

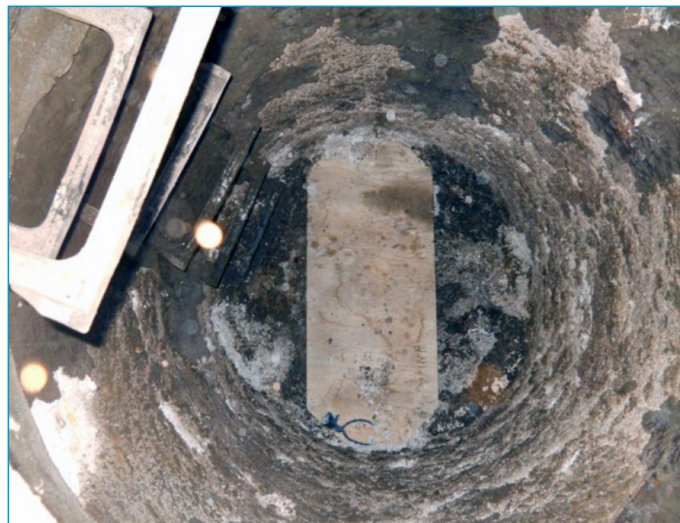
This manhole was selected by KCMO as a trial/demonstration for Quadex GeoKrete. This structure was subjected to high levels of H²S with the upstream manhole being a force main receiving manhole. H²S levels ranged from 165-190 ppm.

The manhole was prepped using a 4,000 psi water blaster.
The joints were sealed with Quadex Hyperform.

The manhole was lined with 1 ½ inches of Quadex GeoKrete, which provides a monolithic, fully structural, corrosion resistant liner at the most economic pricing available. Yet again, another successful in-field trial of Quadex GeoKrete.
