CASE STUDY: MANHOLE REHABILITATION PILOT TEST - SHREVEPORT, LA

- **PROJECT:**
GeoKrete Manhole Rehab Trial
- **OWNER:**
City of Shreveport
- **PROBLEM:**
Highly corroded manhole in need of corrosion protection
- **APPLICATION:**
 - > HyperForm Rapid Setting Patching Material
 - > GeoKrete - 1 1/2" on walls and up to 4" in other places.
 - Troweled to smooth finish.

GeoKrete Selected for Manhole Rehabilitation Test and Exceeds Expectations

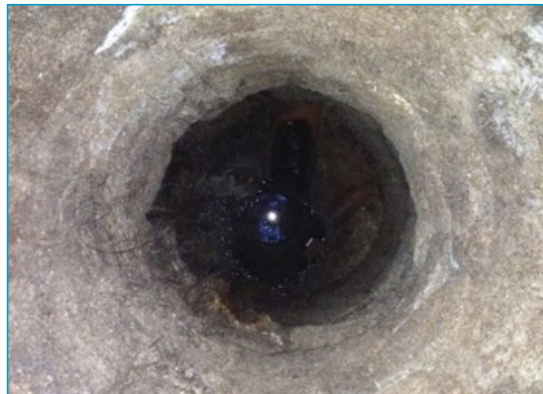
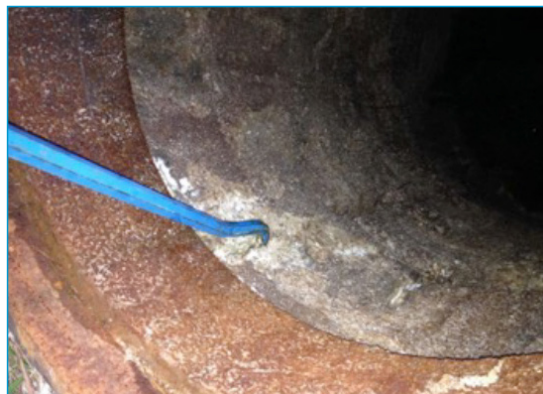
This was a highly corroded manhole picked by the City of Shreveport as a trial / demonstration for Quadex GeoKrete, a structural, corrosion resistant geopolymer mortar. This manhole was approximately 10 ft. in depth and had a forcemain dumping in. The manhole was in desperate need of a structural lining system with extreme corrosion resistant properties.

A 4,000 psi water blast to clean the substrate. The City of Shreveport provided a Vac truck to help remove the enormous amount of gypsum that was cleaned from the manhole walls. All mortar between the concrete blocks was gone due to MIC (microbiologically induced corrosion). Quadex utilized its rapid setting patching material (Hyperform) to rebuild the bottom and create a flow channel for the incoming force main.
