GEOPOLYMER RELINING AND STRUCTURAL RESTORATION OF AGING SEWER INTERCEPTORS IN QUEENS, NY

Queens, NY Sewer Interceptor Rehabilitation Project

NYC Department of Design and Construction (DDC)

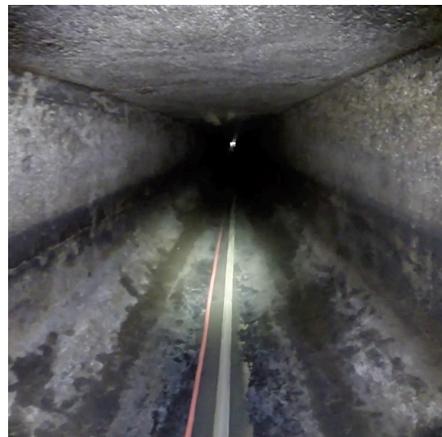
Box Culvert prepped for lining.

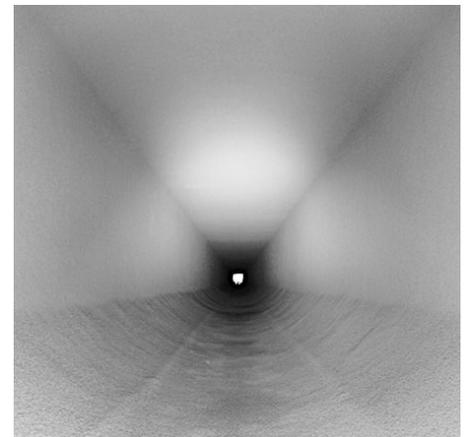
Box Culvert after GeoKrete Geopolymer lining.

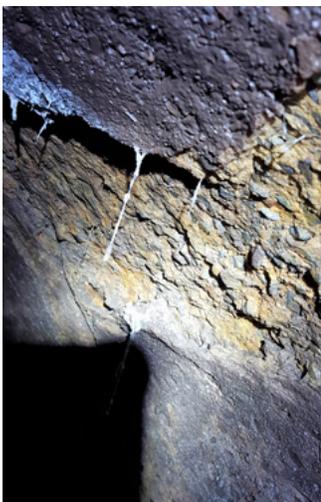
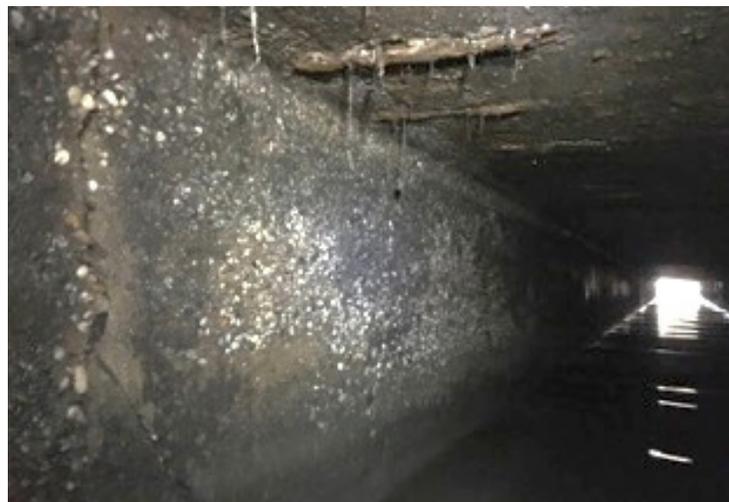
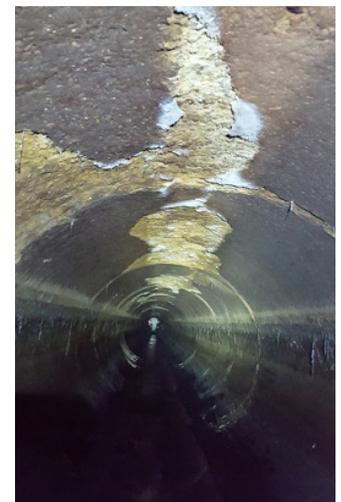
An aging sewer infrastructure combined with severe corrosion and the negative impact from Hurricane Sandy led to a major rehabilitation and structural restoration effort.
