- Grand Chute - Menasha West
- Interceptor Lines - Manhole Relining

MANHOLE REHABILITATION

Manholes Rehabilitated with GeoKrete® Still Looking Good After 10 Years.

SAME MANHOLES ORIGINALLY LINED WITH POLYUREA COATING FAILED AFTER ONE YEAR.

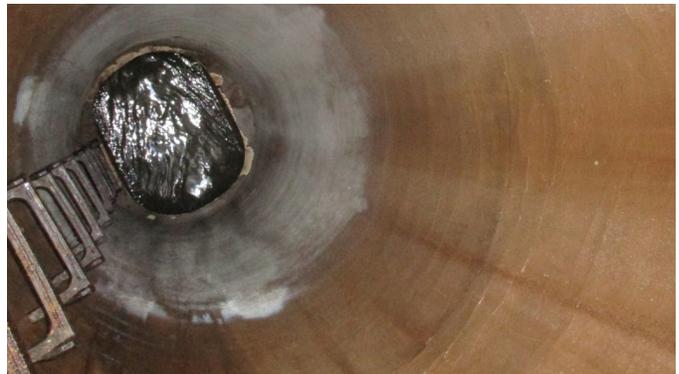
2016

Same manholes 10 years after being relined with GeoKrete.

Rodney Manthey, from the Grand Chute-Menasha West Sewer Commission recently inspected the same manholes and reported that after 10 years the manholes show no signs of failure and are still in excellent condition.

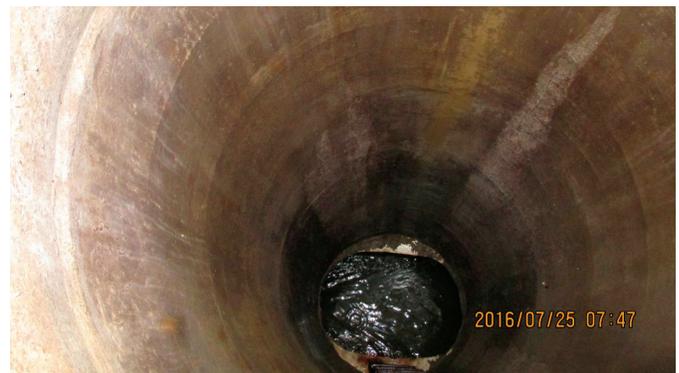
No visible evidence of manhole deterioration.

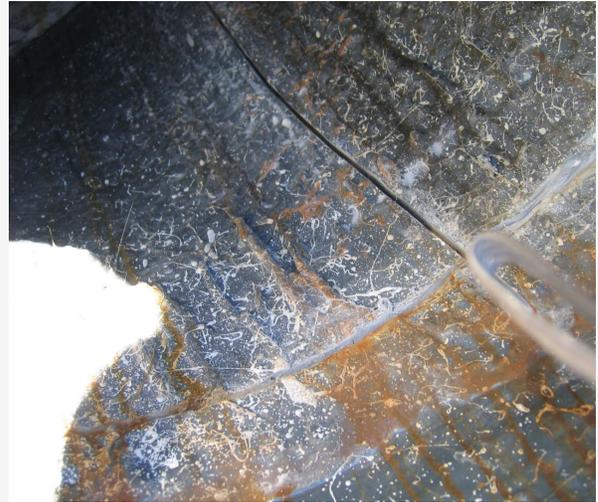
In 2006 an annual inspection of manholes on Butte Des Morts Beach Road in Neenah, WI, revealed a lining failure of more than a dozen manholes that had been rehabilitated with a polyurea coating just one year prior. Extensive flaking and peeling was already present indicating a complete failure was imminent.

Polyurea coating peeled and flaked, exposing the concrete manholes to hydrogen sulfide gas and consequential corrosion.

Rather than re-coat the manholes with the same material, the Grand Chute- Menasha West Sewer Commission instead chose to reline them with a much more robust material, GeoKrete® Geopolymer, manufactured by Quadex LLC., as recommended by a local manhole rehabilitation specialty company, Hydro-Klean (formerly Infratech).

Once the manholes were properly prepped, GeoKrete was applied using a spin-casting apparatus to ensure a consistent and even coating from top to bottom. Only one pass was required for specified coverage. Then the contractor used trowels to smooth out the finish. GeoKrete has an excellent cure rate, and the manholes do not have to be taken out of service.

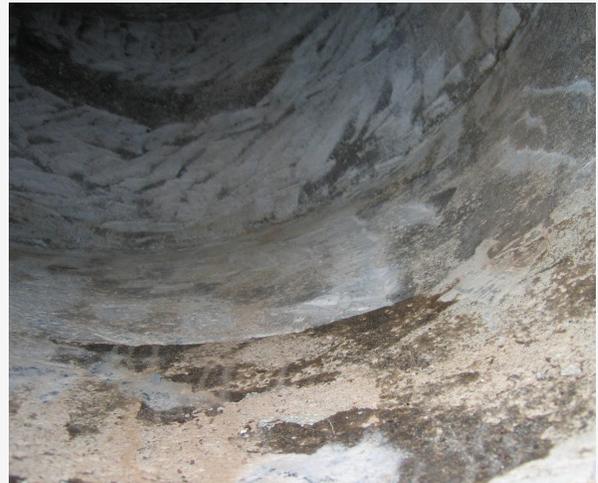
Failed Polyurea coating was removed before new GeoKrete coating was applied.
