GEOKRETE® SOLUTION TO REHABILITATE CMP CULVERT BENEATH MAJOR CONNECTICUT HIGHWAY

- Reidville Drive Culvert Rehabilitation

- City of Waterbury, CT

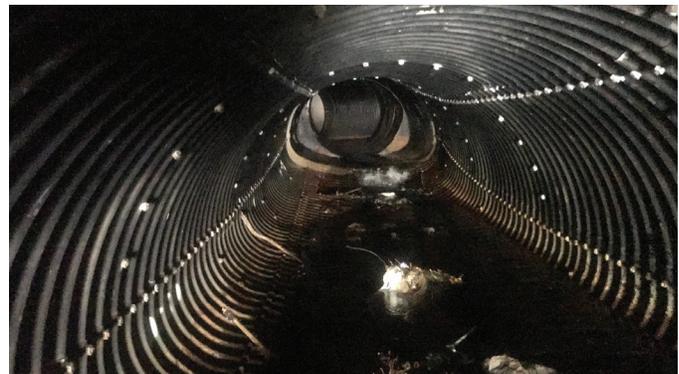
Collapsing culvert prior to QLS installation.

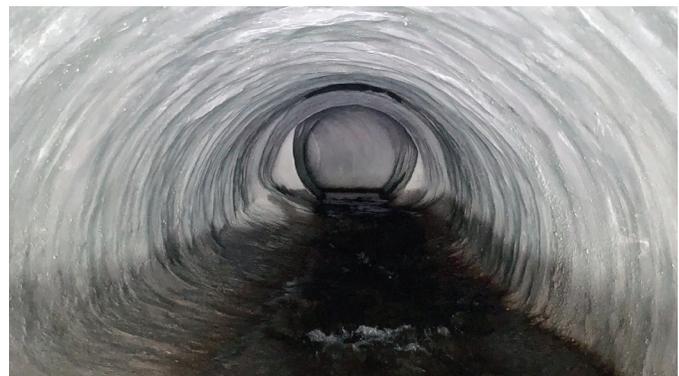
Culvert after full structural rehabilitation using GeoKrete geopolymer.

After cleaning and prepping the 130' long culvert, larger voids were filled and patched before spray apply the GeoKrete. Over the next few days, the QLS crew spray-applied to a uniform thickness of 2", then smooth finished with a trowel. At this thickness, there was only minimal reduction in flow capacity.

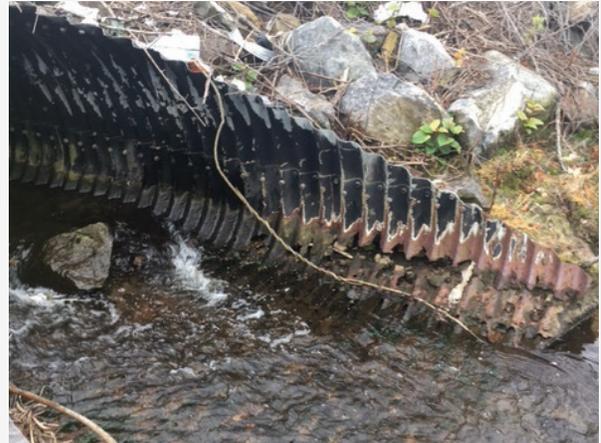
Corrosion in the invert weakened the culvert and also caused severe I/I.

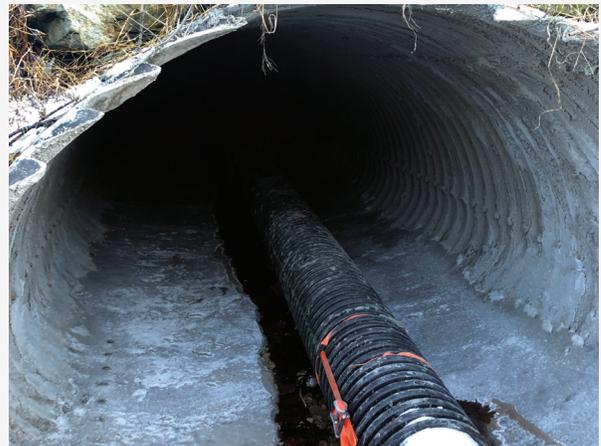
A completely internal bypass system, including a bulkhead, was installed to capture and control stormwater flow during the project.

An advantage of the QLS process is that GeoKrete can bond to itself, allowing the crew to apply in a controlled fashion and even stop and restart if necessary. Additionally since this project called for hand spray application the bypass was able to be set up inside the large culvert. To achieve this, a bulkhead was installed upstream that allowed flow to build up and then be gravity-fed into a 18" HDPE bypass pipe. This innovative approach allowed the entire scope of the project to be performed in a completely trenchless manner, with no impact to the heavily used road overhead.

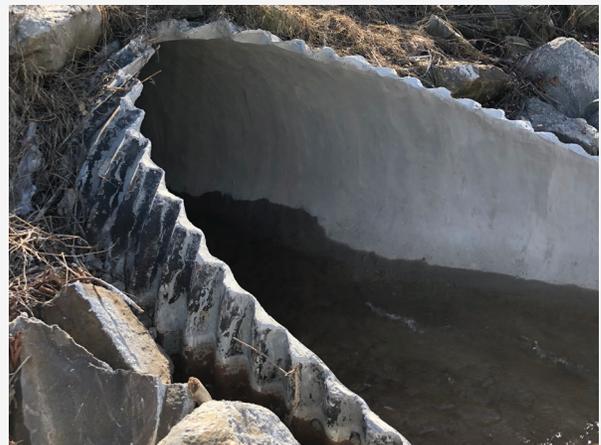
GeoKrete can be hand or spray applied depending on shape and condition of the pipe or structure.
