GeoKrete®

Geopolymer Mortar

For raw, storm and wastewater infrastructure rehabilitation.
Manholes | Tunnels | Culverts | Pipe | Wet Wells | And More...

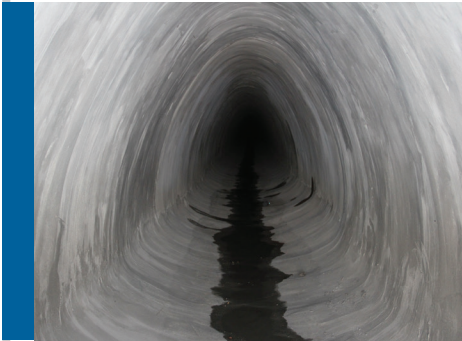
129' DEEP MANHOLE/350' EGG-SHAPED CULVERT REHABILITATION

A 129' deep brick manhole constructed in 1912, along with a 350' of 78"H x 66"W brick culvert built in 1915, had reached the end of their useful lives and were in a state of imminent failure.

- Shear depth of the manhole presented challenges. A specially equipped man lift was used to lower crew into manhole.
- 15 large baffles originally built into the manhole structure had to be removed and the voids repaired.
- The culvert outfall was at the base of a steep slope with 60° incline; made access difficult.

The Quadex Lining System® featuring GeoKrete geopolymer. Installation thickness optimized applying varying thicknesses ranging from 1" to 3" to provide a fully structural renewal and eliminate I&I.

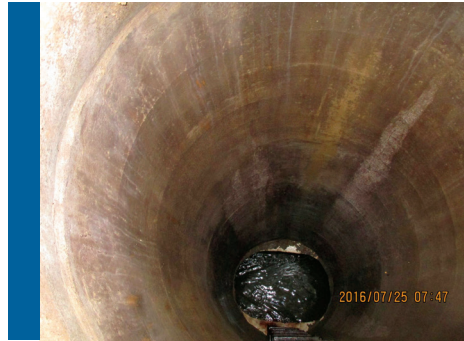
10-YEAR FOLLOW-UP ON GEOKRETE LINED MANHOLES

15 manholes located in Northern Wisconsin, previously coated with a polyurea, were already failing after one year. Extensive flaking and peeling was present indicating a complete failure was imminent.

Quadex® GeoKrete geopolymer was specified to correct the problem and applied with the spinMASTER® system to ensure a consistent lining from top to bottom. A trowel was then used to smooth-out the finish. Since GeoKrete has a quick cure time, the manholes did not have to be taken out of service.

In 2016 the manholes were re-inspected. There were no signs of failure or degradation.

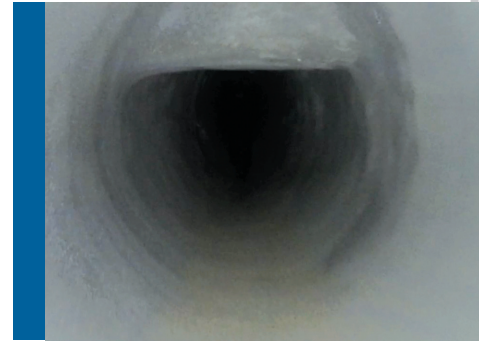
BRICK SEWER REHABILITATION IN FRONT OF BOSTON GENERAL HOSPITAL

A section of an old sewer was odd shaped, contained obstructions and could not be CIPP lined. Since it was located near the hospital entrance a trenchless solution was the only option.

The Quadex Lining System, featuring GeoKrete, was used to reline and structurally restore 415' of 54'H x 36'W brick sewer. It was spray-applied to the odd-shaped sewer and was able to cover the obstructions as well.

GeoKrete Geopolymer liner is still in the same condition as the day it was installed.
