FAILED T-LOCK LINED MANHOLES REHABILITATED WITH STRUCTURE GUARD® 100% SOLIDS EPOXY

10 Sanitary Sewer Manholes Were Corroded From H₂S Gas Exposure Over Time.

- City of Peoria Manhole Rehabilitation

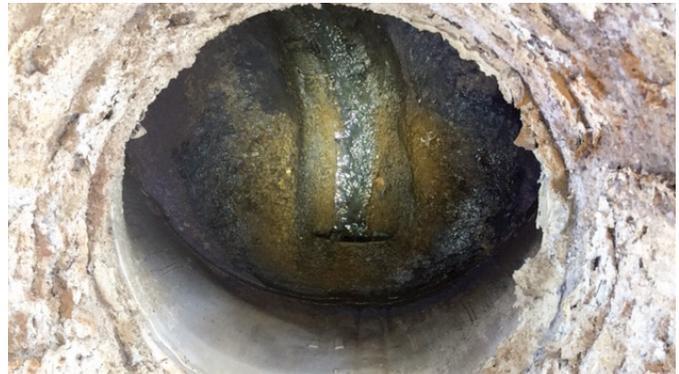
Before

- 10 T-Lock lined manholes that failed and corroded behind the liner

Through routine inspection, a crew from the City of Peoria, AZ Public Works Department identified 10 T-Lock lined sanitary sewer manholes suffering from excessive corrosion and in need of repair and protection. This was a gravity line requiring a lift station to pump to maintain flow. However, once the lift station stops pumping, gases sit in the line until the next time pumping was required. Over the years, the H₂S gas was able to work its way between the liner and walls creating an environment for corrosion.

Over a period of twelve days, all 10 manholes were stripped of T-Lock, cleaned, prepped and then lined with Structure Guard, which was hand nozzle spray applied to a 250 mil thickness for maximum corrosion and leak protection. Hunter Contracting utilized its sprayMASTER® II polymeric lining rig developed by the Vortex Companies, to perform the job. The sprayMASTER II is a completely self-contained system built onto a trailer. It's ability to both mix and pump out of the same trailer is not only safer, but requires less equipment and a smaller construction footprint.
