KCMO MANHOLE REHAB TRIAL USING GEOKRETE®

GeoKrete Excels in Manhole Rehab Trial Where H₂S Levels Very High

- GeoKrete® Manhole Rehab Trial

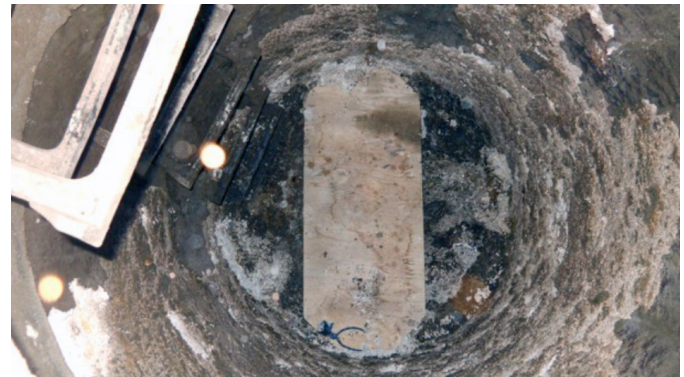
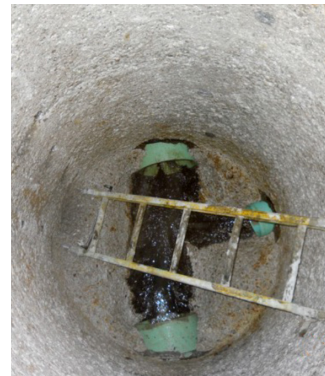
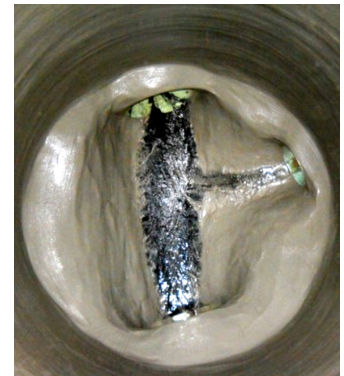
- Highly corroded manhole, connected to force main, in need of corrosion protection. H₂S levels ranged from 165-190 ppm.

This manhole was selected by KCMO as a trial/demonstration for Quadex® GeoKrete®. This structure was subjected to high levels of H₂S with the upstream manhole being a force main receiving manhole. H₂S levels ranged from 165-190 ppm.

The manhole was prepped using a 4,000 psi water blaster. The joints were sealed with Quadex Hyperform®.

The manhole was lined with 1 1/2" of Quadex GeoKrete, which provides a monolithic, fully structural, corrosion resistant liner at the most economic pricing available. Yet again, another successful in-field trial of Quadex GeoKrete.
