CASE STUDY

129' DEEP MANHOLE AND 350' LONG EGG SHAPED OUTFALL PRESENTED SEVERAL CHALLENGES

- Madison-Riverside Drop Manhole Modification and Rehabilitation Project

Superior Performance Properties of GeoKrete® Geopolymer Structurally Restores and Protects 100+ Year-Old Sewer

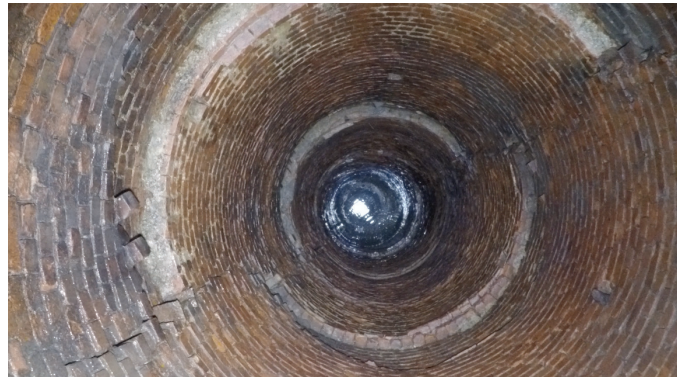
Multiple baffles had to be removed prior to rehabilitating the noticeably cracked 125' deep manhole.

In addition to standard prep, which included pressure washing and patching of cracks and gaps, 15 crumbling concrete baffles built into the walls of the deep manhole had to be removed. The large voids created by their removal also had to be reinforced and filled. To accomplish this, a two-man crew was lowered into the manhole in a basket operated by a crane. This same procedure was used to apply the GeoKrete during the application process.

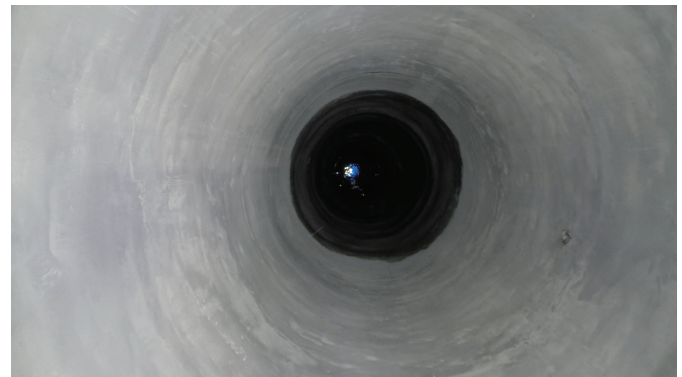
Manhole after QLS GeoKrete lined.

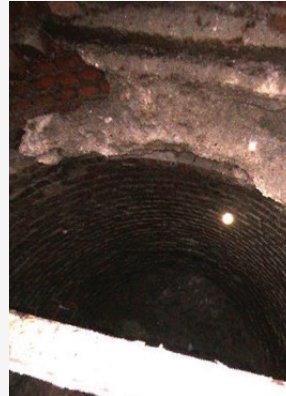
15 concrete baffles, like this damaged one shown, had to be removed from the manhole.

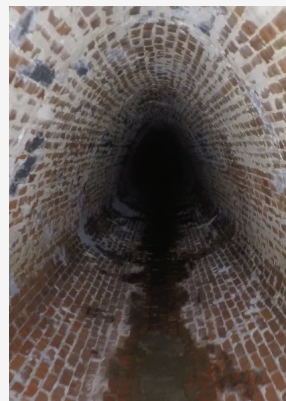
Before: Egg shaped brick outfall.

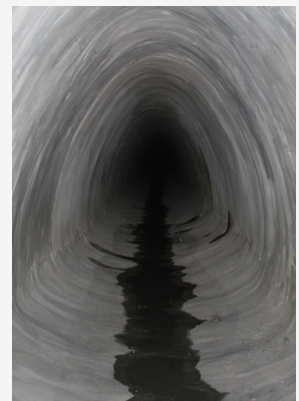
After: Outfall lined with QLS GeoKrete.

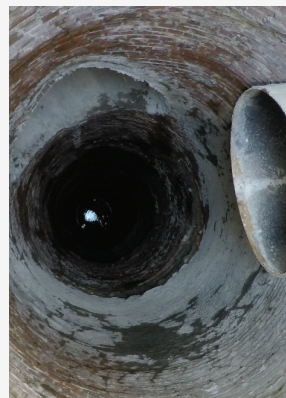
Before: Total restoration was required to bring the sewer back to original operating conditions.
