50 YEAR-OLD, DETERIORATED STEAM TUNNEL ON UNIVERSITY OF PITTSBURGH CAMPUS STRUCTURALLY REHABILITATED WITH GEOKRETE® GEOPOLYMER

- University of Pittsburgh - 5th Avenue Steam Tunnel Rehabilitation (Pittsburgh, PA)

- 94 LF of 84-inch steel plated tunnel

- Spray apply QLS GeoKrete® Geopolymer for full circumference lining after floor was raised and leveled by Quad-Flow.

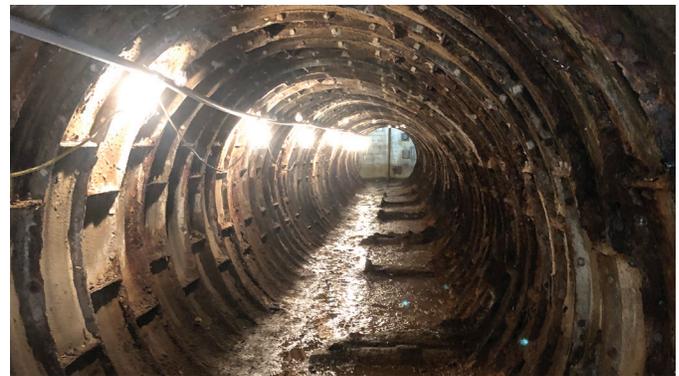
Located below and in front of the University of Pittsburgh's prestigious Cathedral of Learning, a 50 year-old steam tunnel serving the campus's utilities was in dire condition. The 84-inch diameter, 94-foot long steel plate tunnel was extremely deteriorated and corroded.

Condition of steam tunnel proper to QLS/GeoKrete® installation.

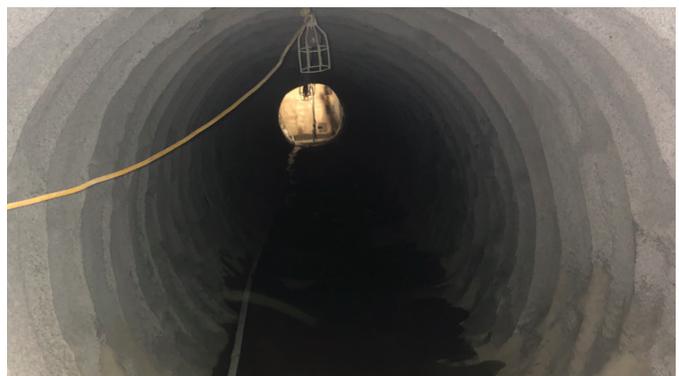
After the steam tunnel is lined with GeoKrete and floor leveled with Quad-Flow.

To achieve this, the QLS crew recommended Quadex Quad-Flow for its high-build, self leveling properties. Once the floor was cured, Wayne Crouse was ready to install the supports for brackets and piping. QLS then lined around these supports, allowing them to follow with bracket and piping installation.

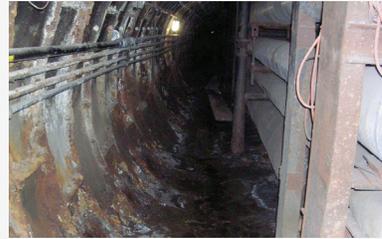
Condition of the tunnel and placement of the conduit prior to removal and rehabilitation.

Prior to the lining process, all piping and brackets needed to be removed. It was also determined that the invert of the pipe needed to be raised 1.5" and then leveled to a flat surface bottom to make is safer for maintenance crews to walk through the tunnel in the future.

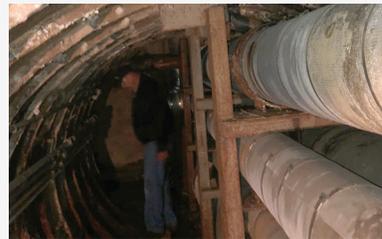
Severe corrosion threatened the structural integrity of the old steam pipe.

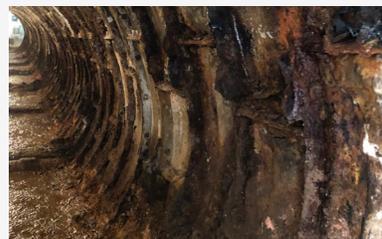
The old piping and conduit was removed prior to relining the tunnel with QLS/GeoKrete.

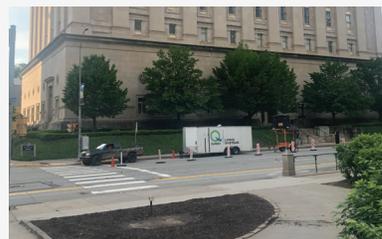
Note the small construction footprint of the QLS system.

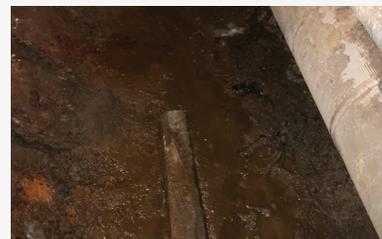
The original rounded floor of the steam tunnel was not only slippery, it was difficult for maintenance crews to gain purchase.

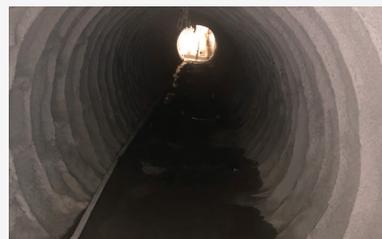
After 1.5" of QLS GeoKrete was spray-applied to structurally renew the deteriorating steam tunnel.

Truly a collaborative effort, all parties worked together to achieve the desired results: A fully structural restoration, using a monolithic liner to eliminate all possibilities for future leaks and corrosion. Finally, it was completed by trenchless means, allowing the University to keep the Cathedral of Learning open throughout the entire process.
