CASE STUDY

SOUTH ADAMS COUNTY, COLORADO DISTRICT SANITARY SEWER REHABILITATION

Pipe and Manholes Fully Restored
with Materials Designed to
Withstand Harsh Winters and
Extremely Cold Conditions

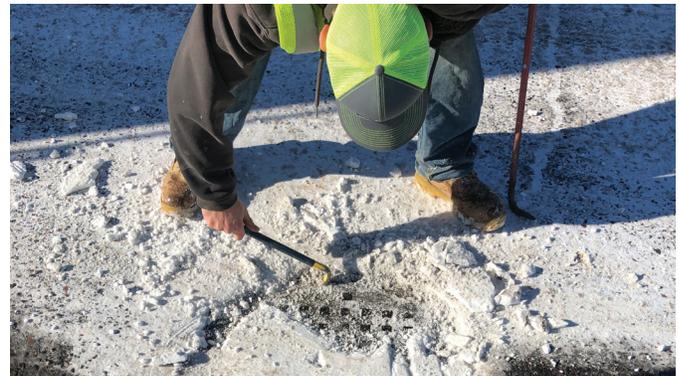
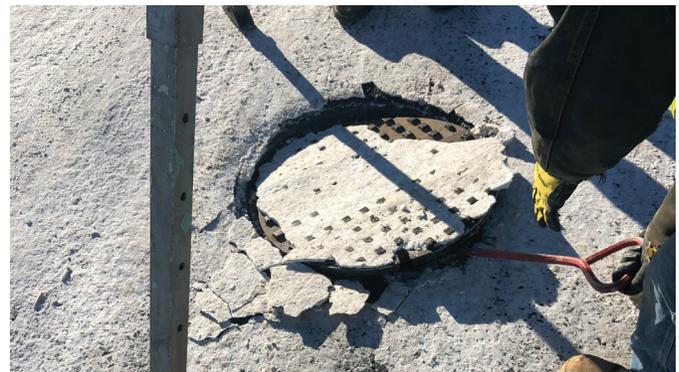
*Cold winter conditions not only impacts the installation crew,
it takes its toll on the manholes as well.*

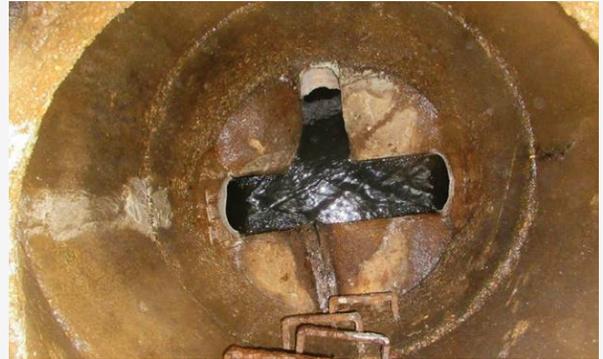
Extreme and harsh winter weather conditions are a part of life in South Adams County, Colorado. So it is no surprise its sanitary sewer pipes and manholes were found to be suffering from severe deterioration and I&I. Rather than dig and replace, both the pipe and manholes could be fully restored and protected through trenchless rehabilitation means.

Typical manhole condition prior to lining with QM-1s Restore.

To address the pipe and manhole concerns, the engineer and general contractor recommended two courses of action. Clearly the pipe was to be CIPP lined. However, due to the degradation of the manholes, they would require more attention. To address the loss of structural integrity, the manholes would be lined with Quadex® QM-1s Restore®, a cementitious mortar known for its structural restoration properties. The engineer called for Quadex Structure Guard®, a 100% solids epoxy spray, to be applied at a thickness of 125 mils to add the needed corrosion protection.

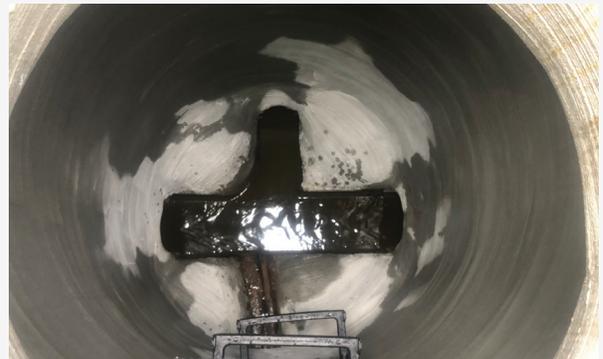
Manhole lined with QM-1s Restore and ready for Structure Guard epoxy coating for corrosion protection.

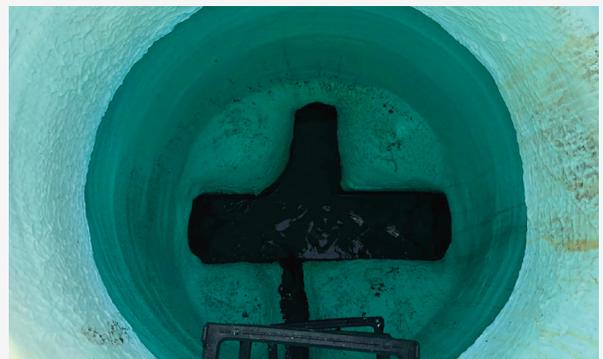
Structure Guard 100% solids epoxy was applied at 125 mils, to provide corrosion protection.

Post installation testing of the Structure Guard epoxy revealed adhesion levels that exceeded the expectations of county officials. Visual inspections also showed clean, smooth finished manholes in spite of the less than desirable weather conditions faced by the crew.
