LINING  
SYSTEMS  
A VORTEX COMPANY

## GEOPOLYMER RELINING AND STRUCTURAL RESTORATION OF AGING SEWER INTERCEPTORS IN QUEENS, NY

Queens, NY Sewer Interceptor Rehabilitation Project

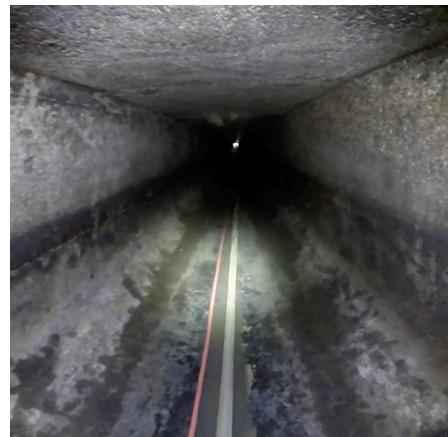
Box Culvert prepped for lining.

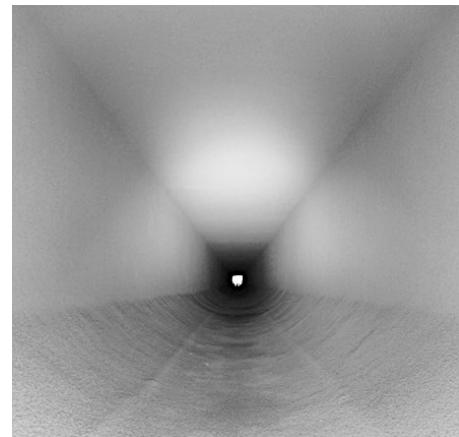
Box Culvert after GeoKrete Geopolymer lining.

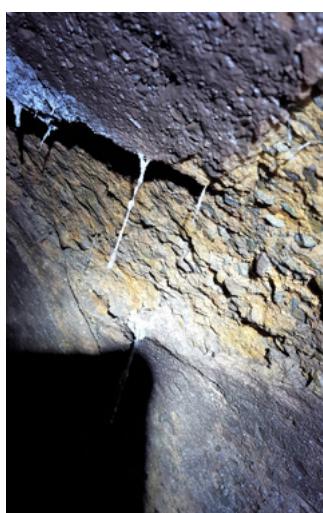
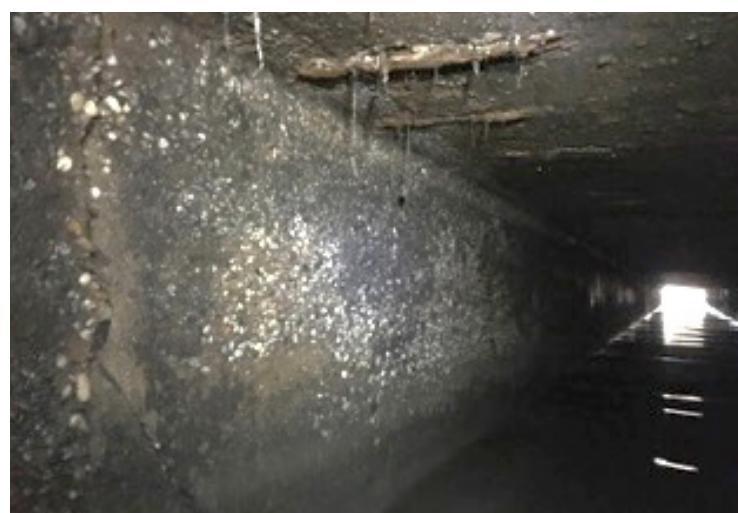
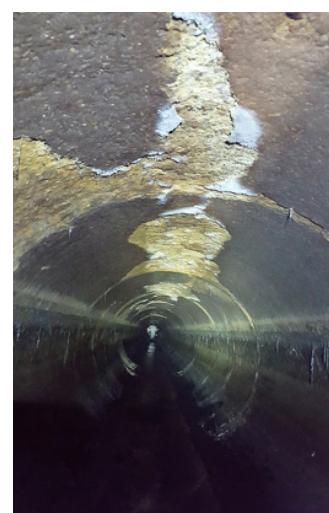
An aging sewer infrastructure combined with severe corrosion and the negative impact from Hurricane Sandy led to a major rehabilitation and structural restoration effort.
