SOUTH ADAMS COUNTY, COLORADO DISTRICT SANITARY SEWER REHABILITATION

PIPE AND MANHOLES FULLY RESTORED WITH MATERIALS DESIGNED TO WITHSTAND HARSH WINTERS AND EXTREMELY COLD CONDITIONS

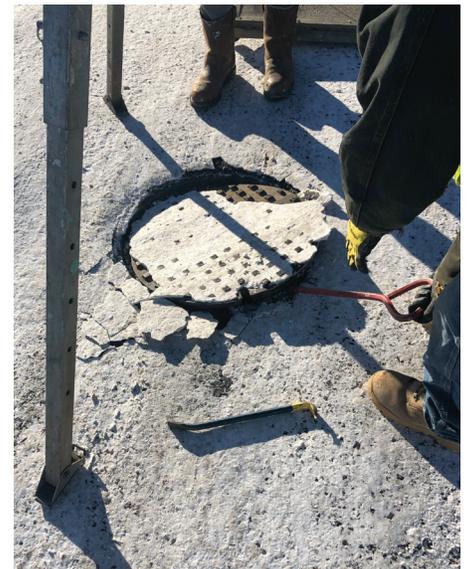
Cold winter conditions not only impacts the installation crew, it takes its toll on the manholes as well.

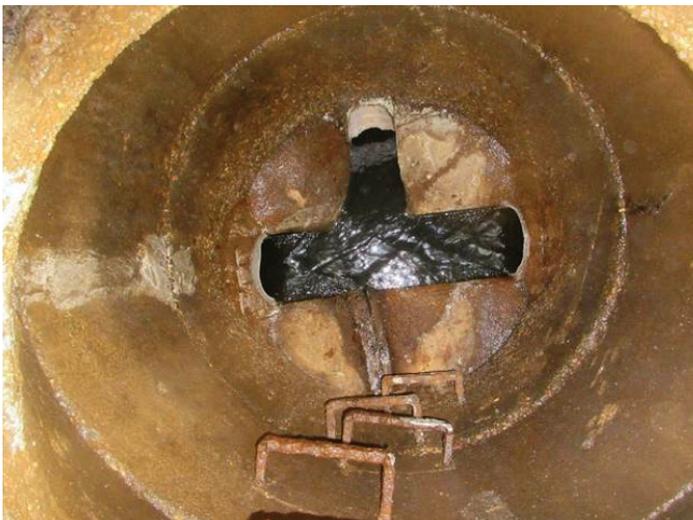
Typical manhole condition prior to lining with QM-1s Restore.

To address the pipe and manhole concerns, the engineer and general contractor recommended two courses of action. Clearly the pipe was to be CIPP lined. However, due to the degradation of the manholes, they would require more attention. To address the loss of structural integrity, the manholes would be lined with Quadex® QM-1s Restore®, a cementitious mortar known for its structural restoration properties. The engineer called for Quadex Structure Guard®, a 100% solids epoxy spray, to be applied at a thickness of 125 mils to add the needed corrosion protection.

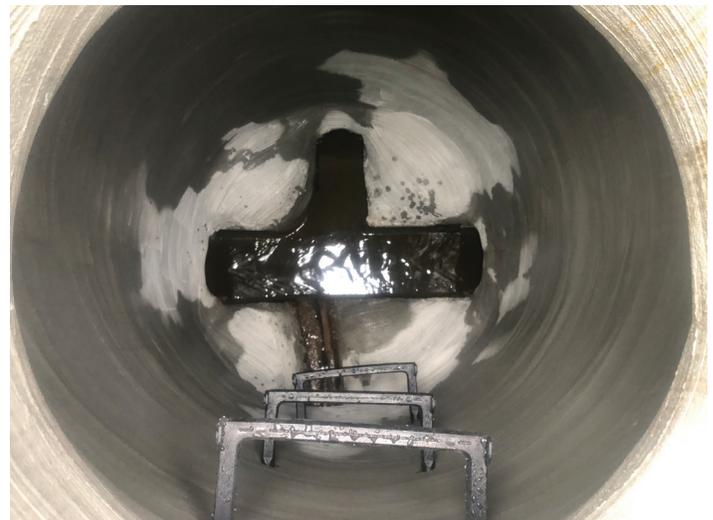
Manhole lined with QM-1s Restore and ready for Structure Guard epoxy coating for corrosion protection.

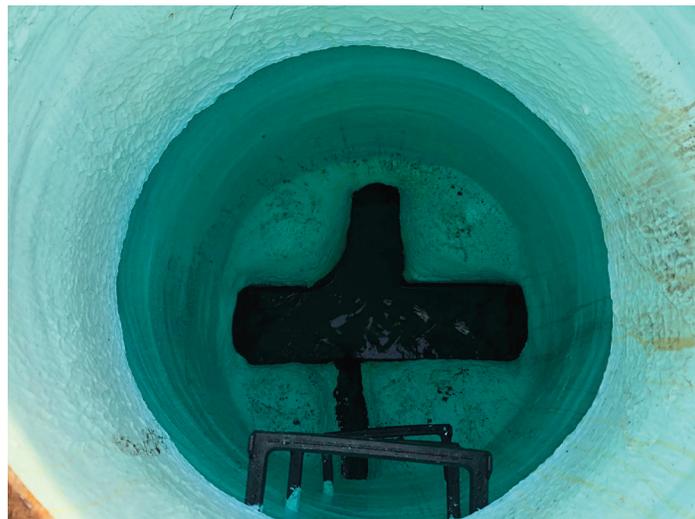
Structure Guard 100% solids epoxy was applied at 125 mils, to provide corrosion protection.

Post installation testing of the Structure Guard epoxy revealed adhesion levels that exceeded the expectations of county officials. Visual inspections also showed clean, smooth finished manholes in spite of the less than desirable weather conditions faced by the crew.
