## WASHINGTON NAVY YARD - STEEL LIFT STATION TANK COMPLETELY REHABILITATED USING STRUCTURE GUARD™ SE 1000 EPOXY

### WASHINGTON NAVY YARD LIFT STATION TANK REHABILITATED WITH STRUCTURE GUARD EPOXY TO ADDRESS CORROSION AND ENVIRONMENTAL CONCERNS

**Project:** Washington Navy Yard – Steel Lift Station Tank Repair

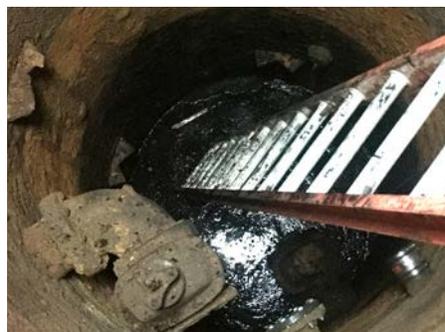
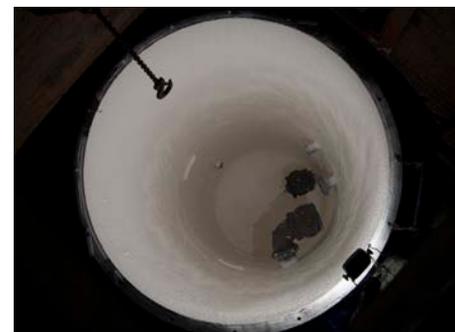
Several rehabilitation methods and materials were initially discussed. They included hybrid cements, geopolymers and epoxies. After taking a site walk and meeting with the Navy Yard and NICC, the Vortex Companies and its partner Stag Technologies recommended **Structure Guard™ SE 1000**. Being a manufacturer of a wide range of rehabilitation mortars and epoxies, the Vortex/Stag team was uniquely qualified to recommend the best possible material application for the project environment. In this case the combination of severe corrosion environment and the tank's proximity to the river, Structure Guard™ SE 1000 Epoxy was chosen as the rehabilitation method.

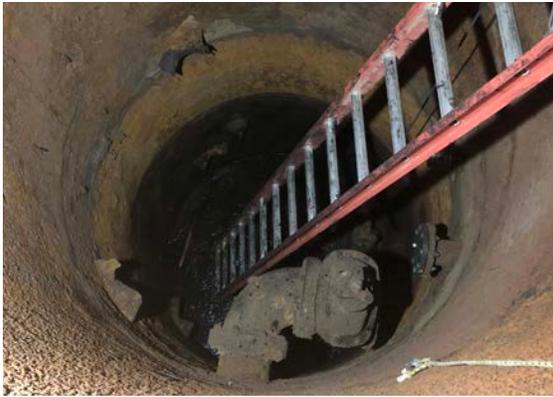
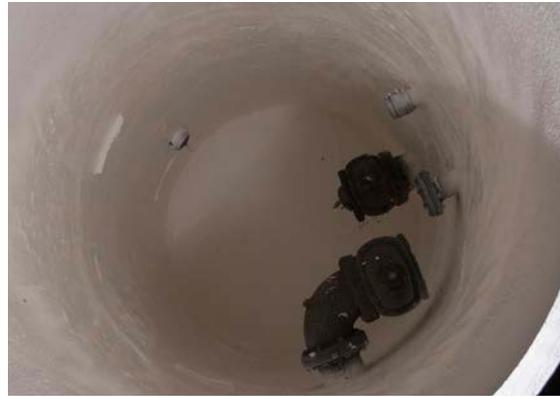
The Vortex/Stag team was able to clean, prep and reline the 60+ year-old lift station tank with Structure Guard™ Epoxy in two days. Although heavy groundwater infiltration was present, the team was able to work around the problem and complete the installation on time and within budget.
