CASE STUDY: GEOKRETE GEOPOLYMER THE PREFERRED CHOICE TO REHAB 40 MANHOLES IN SINGAPORE

- **PROJECT:** Rehabilitation of Sewerage Network System: Phase 4 - Eastern Area Contract 2
- **LOCATION:** East Coast Area, Singapore
- **PROBLEM:** Excessive I/I, and corrosion
- **SOLUTION:** Quadex's GeoKrete Geopolymer spray-applied to 12mm thickness to achieve desired structural integrity and corrosion protection. Troweled to a smooth finish.
- **CONTRACTOR:** PMPS Liner Technologies (s) Pte Ltd
140 Tagore Lane
Singapore
787560
Mr. Jackie Yeo: CEO
jackie@pmpsliner.com
- **PROJECT TIME FRAME:**
4 months
- **CONTACT:**
Mark Pearson
A&S Global Technologies
map@asglobaltech.com

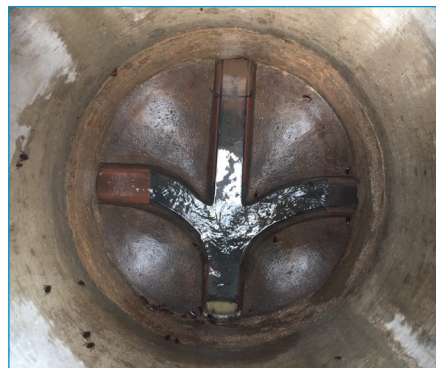
Manhole Before

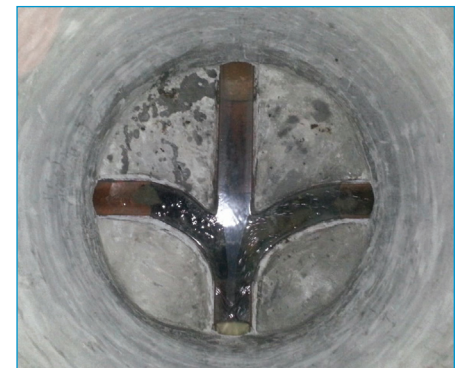
Manhole After

The workers particularly liked the ease of application and the lack of "fall-down" of GeoKrete when compared to other materials. GeoKrete also performed well in 3rd Party testing and the contractor, PMPS Liner Technologies, also demonstrated how easy it was to apply. With those two important factors, GeoKrete was approved. All 40 manholes were rehabilitated over a four month period. To ensure a smooth and consistent wall thickness, a special designed, chain driven, spin-casting spray apparatus was developed. Mounted on a tripod, then centered over the manhole opening, the apparatus is lowered, then raised up and down the manhole until the desired thickness is achieved.
