## MANHOLE REHABILITATION PILOT TEST SHREVEPORT, LA

GeoKrete® Manhole Rehab Trial

**Owner:** City of Shreveport

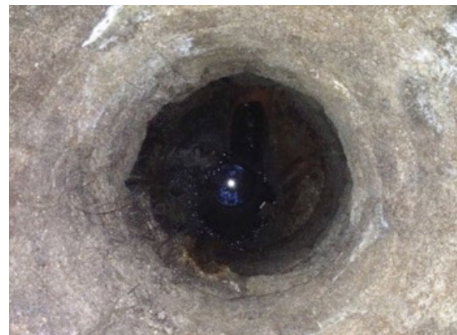
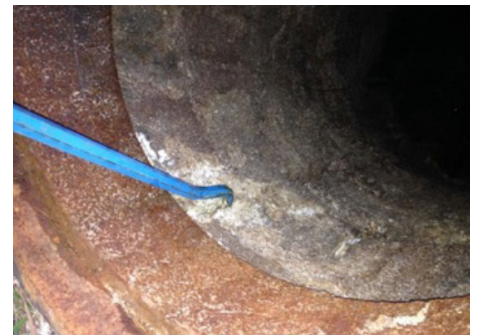
This was a highly corroded manhole picked by the City of Shreveport as a trial / demonstration for Quadex™ GeoKrete, a structural, corrosion resistant geopolymer mortar. This manhole was approximately 10 ft. in depth and had a forcemain dumping in. The manhole was in desperate need of a structural lining system with extreme corrosion resistant properties.

A 4,000 psi water blast to clean the substrate. The City of Shreveport provided a Vac truck to help remove the enormous amount of gypsum that was cleaned from the manhole walls. All mortar between the concrete blocks was gone due to MIC (microbiologically induced corrosion). Quadex utilized its rapid setting patching material (Hyperform®) to rebuild the bottom and create a flow channel for the incoming force main.

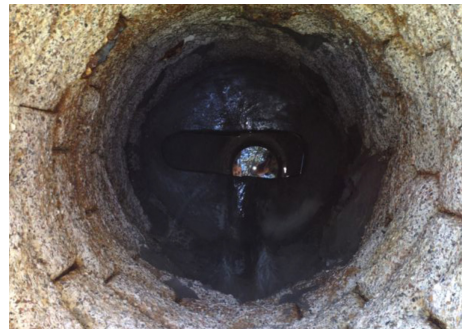
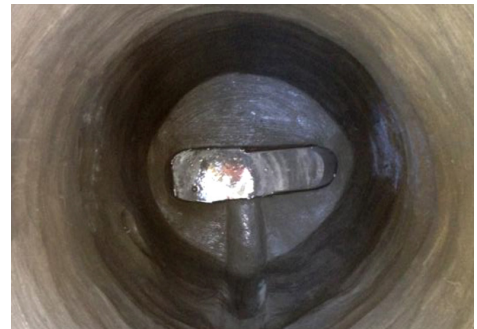
Quadex utilized its GeoKrete geopolymer mortar to structurally restore this manhole to a "better than new" state. The liner averaged 1 ½ inches in thickness with having to apply it upwards of 4 inches in some places.
