## QUADEX® STRUCTURE GUARD® ADDS NEW LIFE TO MANHOLES ON AK-CHIN INDIAN RESERVATION

100% Solids Epoxy Coating  
Prevents Corrosion, I&I and Saves  
Money.

- Ak-Chin Indian Community, Maricopa Indian Reservation Manhole Rehabilitation near the City of Maricopa, AZ Manhole Rehabilitation

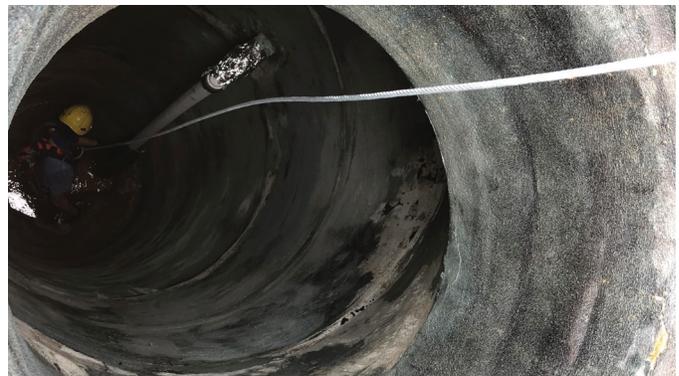
Manhole cleaned and prepped, awaiting structural and corrosion protection.

1. Clean, identify and address any leaks with Quadex I&I Guard®-PRF, a polyurethane chemical grout and Quadex Hyperform®, a one component, rapid-setting, patching water stop material.
2. After prep, trowel apply AluminaLiner® a structural cementitious mortar.
3. After AluminaLiner is cured, spray apply Quadex Structure Guard®, a 100% solids epoxy proven to protect the manholes from corrosion while adding another layer of leak protection. Structure Guard goes on quickly and can be applied up to 250 mils in a single pass. When fully cured it provides a corrosion and leak proof lining and adds an additional 50+ years of design life to a manhole.

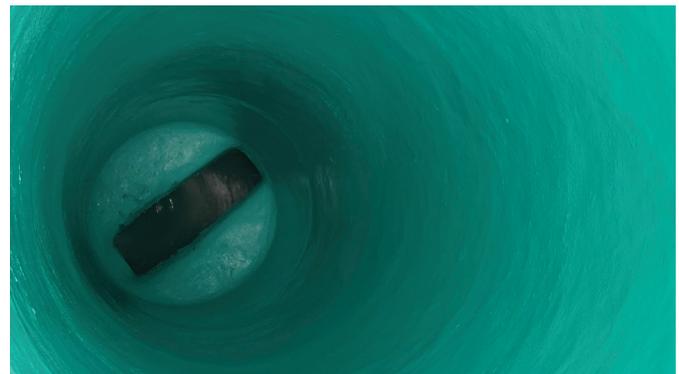
Completed manhole after Structure Guard® spray-applied and troweled to a smooth finish.

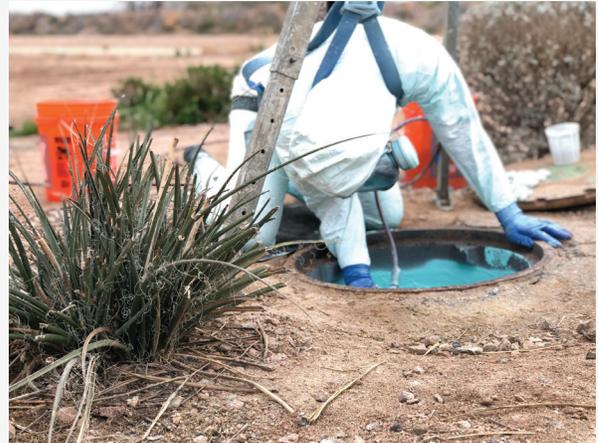
*Structure Guard is easy to apply and allows crews to quickly complete multiple structures in a single day.*

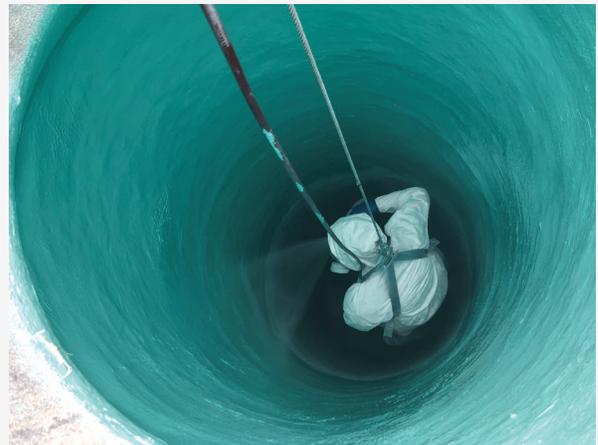
*Structure Guard can be applied up to 250 mils per pass.*
