GEOKRETE® GEOPOLYMER THE PREFERRED CHOICE TO REHAB 40 MANHOLES IN SINGAPORE

- Rehabilitation of Sewerage Network System: Phase 4 - Eastern Area Contract 2

Sewerage System Rehab and Upgrade Utilizes GeoKrete for Manholes

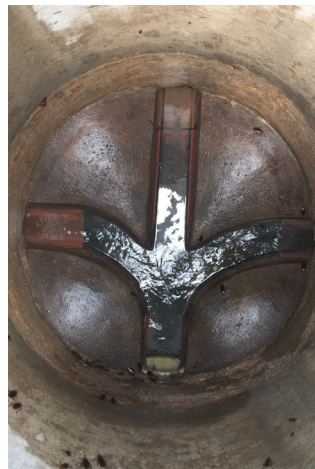
Manhole Before

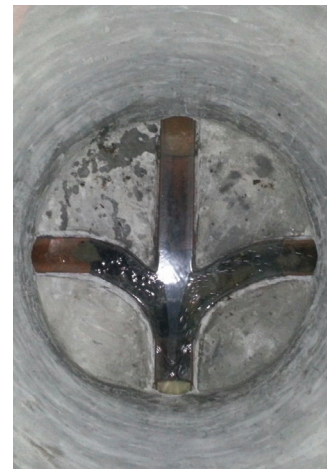
Manhole After

- Quadex®'s GeoKrete® Geopolymer spray-applied to 12mm thickness to achieve desired structural integrity and corrosion protection. Troweled to a smooth finish.
