QUADEX®
A VORTEX COMPANY

GEOKRETE® GEOPOLYMER MORTAR FOR RAW, STORM AND WASTEWATER INFRASTRUCTURE REHABILITATION

SPECIFY GEOKRETE® FOR MANHOLES, TUNNELS & CULVERTS

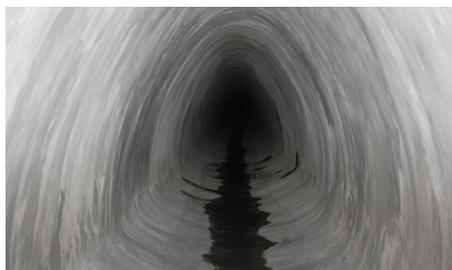
129' Deep Manhole/350' Egg-Shaped Culvert Rehabilitation

A 129' deep brick manhole constructed in 1912, along with a 350' of 78"H x 66"W brick culvert built in 1915, had reached the end of their useful lives and were in a state of imminent failure.

- Shear depth of the manhole presented challenges. A specially equipped man lift was used to lower crew into manhole.
- 15 large baffles originally built into the manhole structure had to be removed and the voids repaired.
- The culvert outfall was at the base of a steep slope with 60° incline; made access difficult.

The Quadex Lining System® featuring GeoKrete geopolymer. Installation thickness optimized applying varying thicknesses ranging from 1" to 3" to provide a fully structural renewal and eliminate I&I.

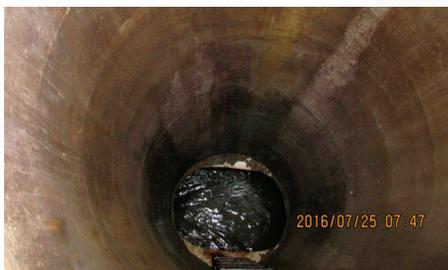
10-Year Follow-up on GeoKrete Lined Manholes

15 manholes located in Northern Wisconsin, previously coated with a polyurea, were already failing after one year. Extensive flaking and peeling was present indicating a complete failure was imminent.

Quadex® GeoKrete geopolymer was specified to correct the problem and applied with the spinMASTER® system to ensure a consistent lining from top to bottom. A trowel was then used to smooth-out the finish. Since GeoKrete has an quick cure time, the manholes did not have to be taken out of service.

In 2016 the manholes were re-inspected. There were no signs of failure or degradation.

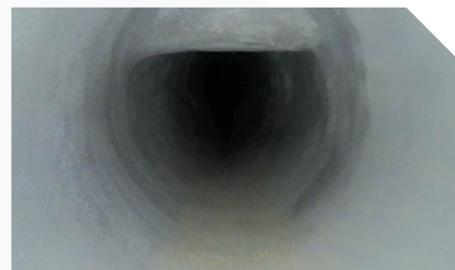
Brick Sewer Rehabilitation In Front of Boston General Hospital

A section of an old sewer was odd shaped, contained obstructions and could not be CIPP lined. Since it was located near the hospital entrance a trenchless solution was the only option.

The Quadex Lining System, featuring GeoKrete, was used to reline and structurally restore 415' of 54"H x 36"W brick sewer. It was spray-applied to the odd-shaped sewer and was able to cover the obstructions as well.

GeoKrete Geopolymer liner is still in the same condition as the day it was installed.
